## **Sample Report**

**Site Visits**  
**Any Capitol, Any State**  
**Date**

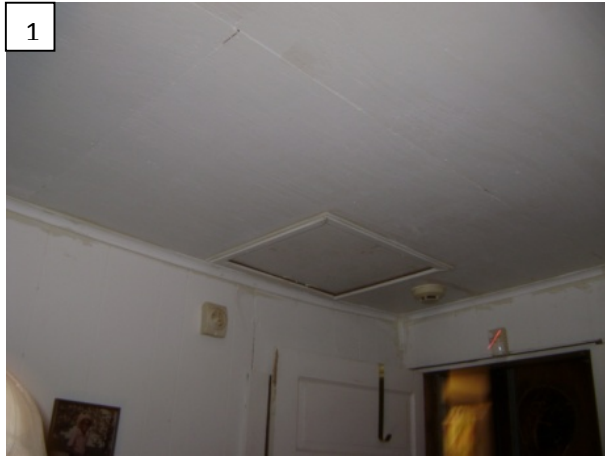
- The attic hatch has no fastening method. It depends on the lid's weight for an air seal. [1]
- The stick-on foam weatherstrip used on the attic hatch does not appear to be very durable. [2] & [3]
- The top of the attic hatch is not insulated. [3]
- The furnace vent stack is elbowed in the attic instead of going straight up through roof. Why? Did the design contribute to failure? [4]
- The attic cellulose blow was somewhat uneven but acceptable. [4]
- The attic wire penetrations were not air sealed. [5]

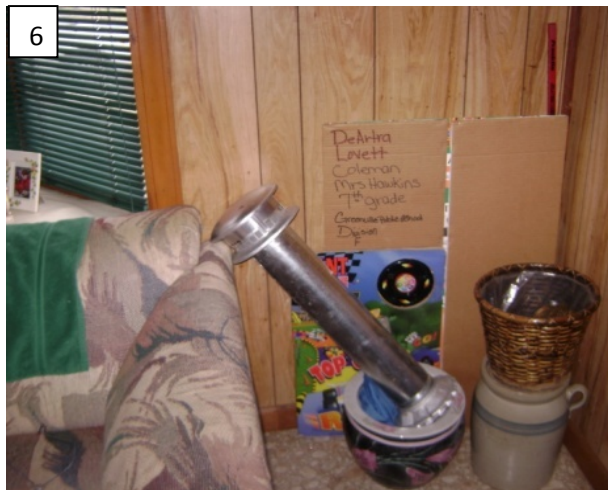
- Wind snapped the newly installed furnace vent stack at the roof line. (CAA had no notice before its arrival and immediately arranged for a repair.) [6]

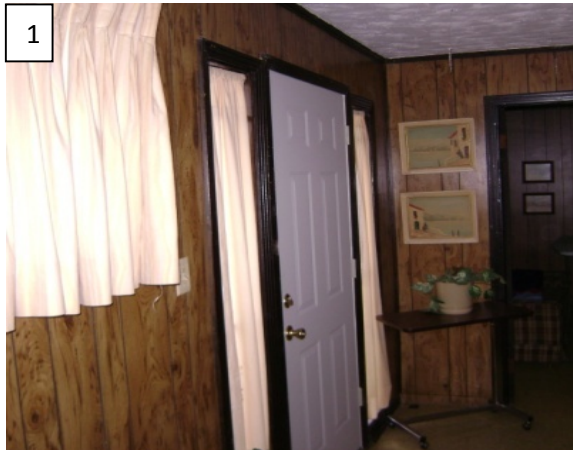
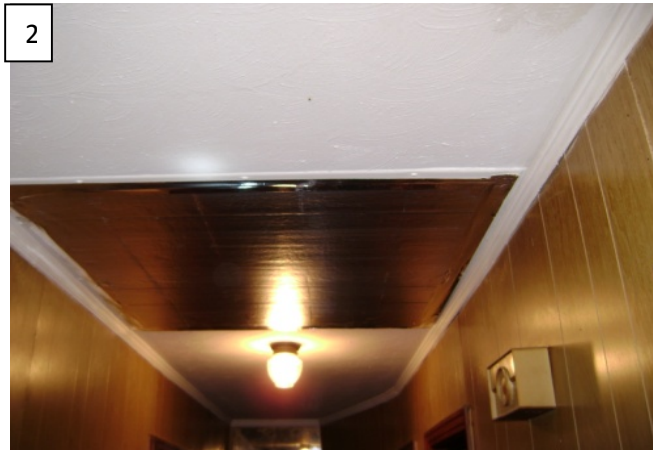
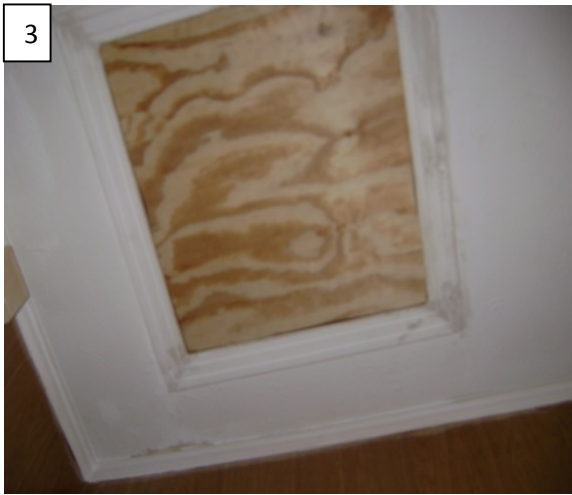
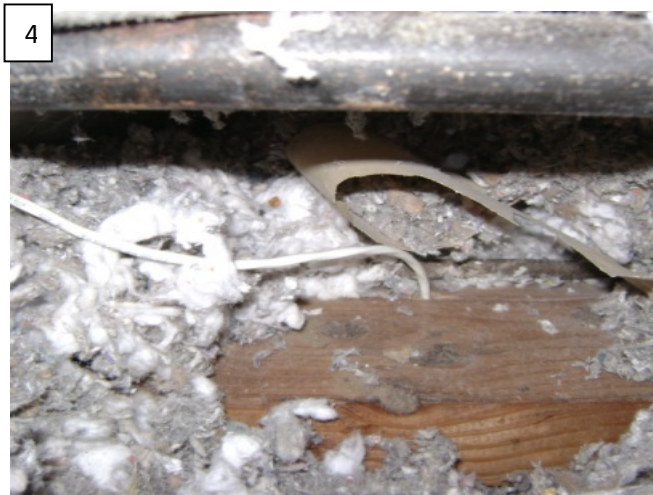
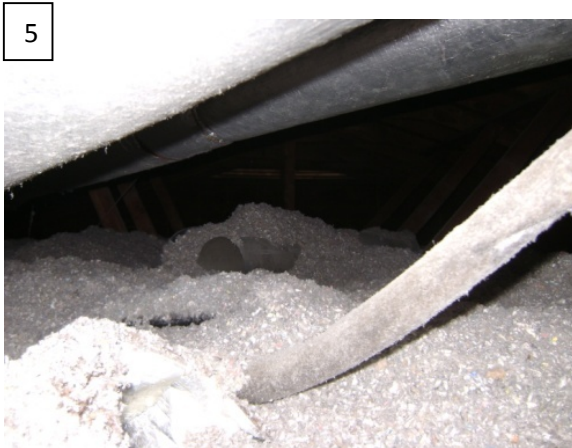
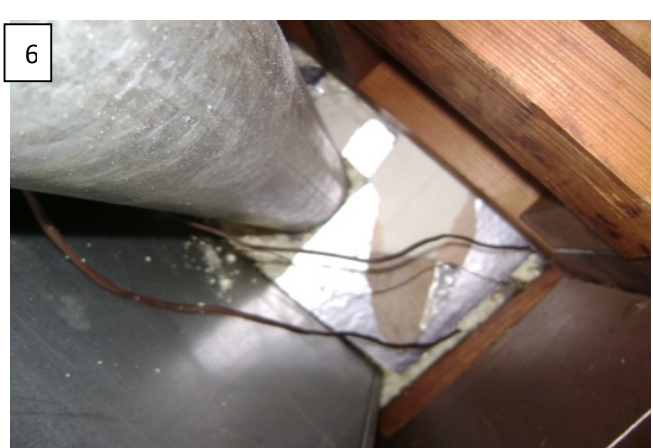
- The whole-house fan cover was attached with foil tape to the fan grille. This work was cosmetically poor and difficult to remove/replace if the client wishes to use the fan. [2]
- Same concerns with attic hatch as in Unit #1. Also, the hatch was not finished to match the home. [3]
- The attic wire penetrations were not air sealed. [4]
- The attic cellulose was very uneven but acceptable. [5]
- The furnace closet ceiling appears leaky. (A blower door test would be necessary to confirm.) [6]

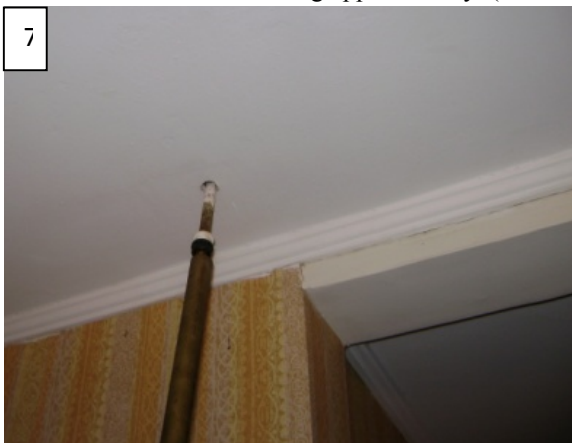
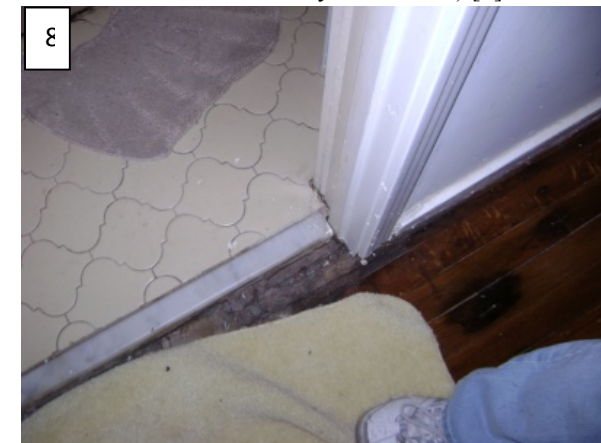
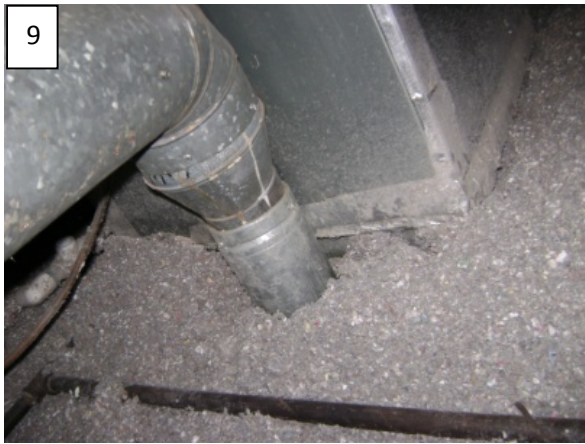
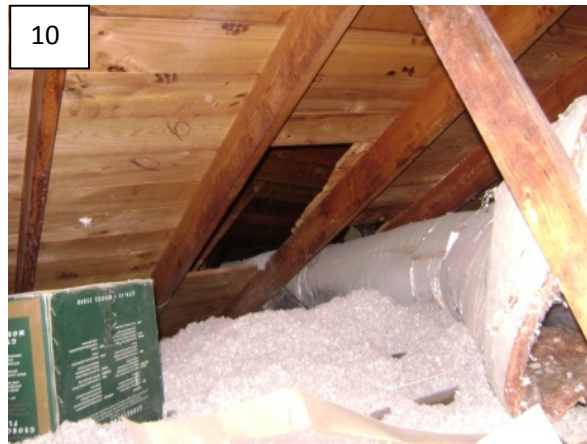
- A hole punched in the ceiling drywall by a pole fixture was not treated. [7]
- A hole leading to the crawl space at the door stool was not treated. [8]
- Plenum joints were sealed with duct tape, rather than mastic and webbed drywall joint tape. [9]
- The plenum was not insulated. [9]
- The heat/AC duct insulation is failing in several places and apparently untreated. [10]
- The team blew insulation over items the client had stored in the attic. [10]

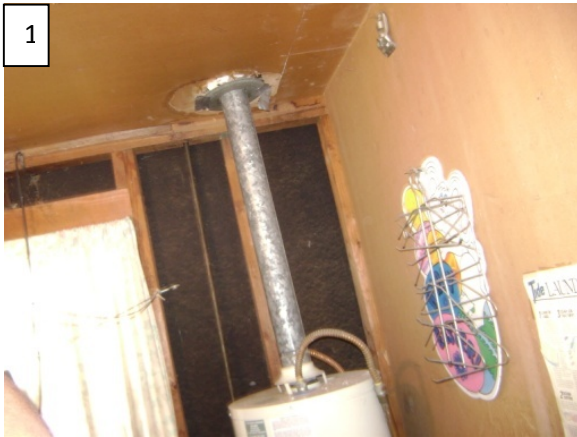
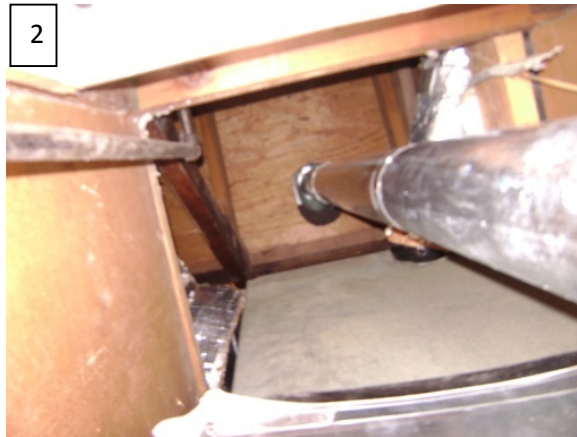
- The water heater in the utility room was accessible only from the carport. There appears to be some confusion about the building envelope (utility room in or out?) as some air sealing was attempted but the walls were left uninsulated. [1]
- Foam was sprayed directly on a gas water heater vent pipe to air seal the utility room ceiling penetration. Does this violate the fire code? [1]
- The furnace closet is open to the attic. The closet door seal appears leaky. No blower door was available for testing. [2]

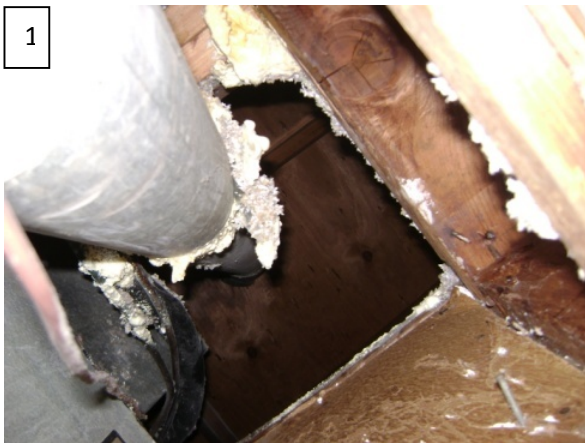
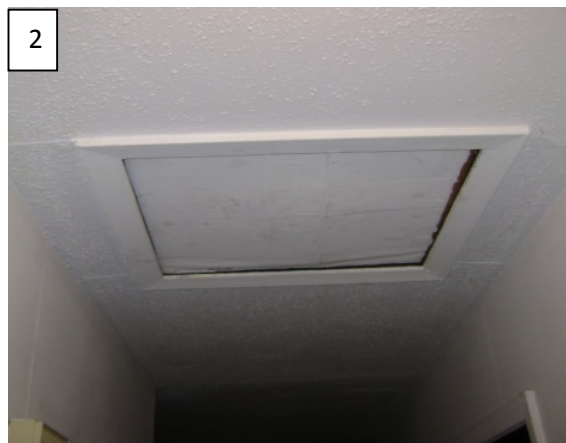
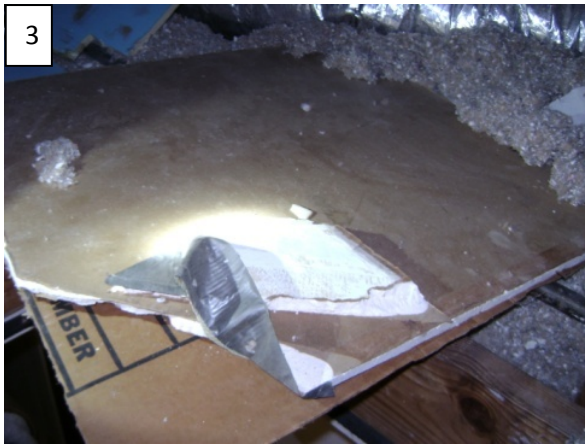
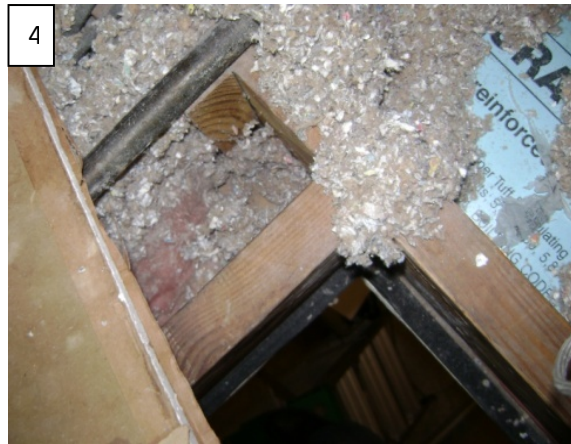
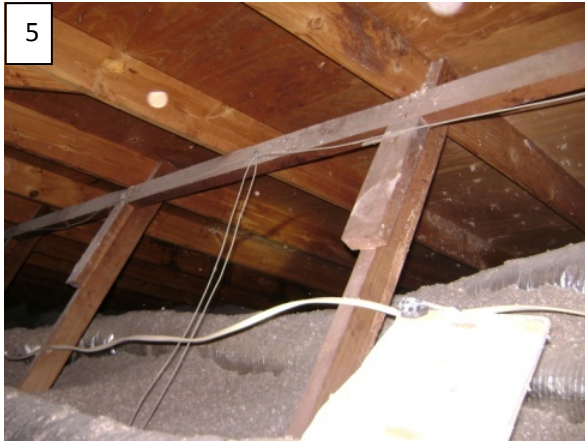
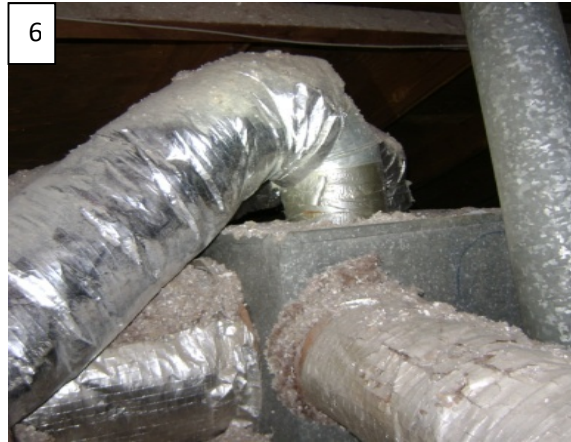
- The pictured air seal of the furnace closet ceiling was very leaky during the blower door test. [1]
- The attic hatch has no fastening method. It depends on the lid's weight for an air seal. [1]
- The attic hatch cover is actually a piece of broken 3/8" drywall with a painted cardboard cover. It's totally ineffective. [2-3]
- The top of the attic hatch was not insulated. [3]
- The stick-on foam weatherstrip used on attic hatch does not appear to be very durable. [4]
- The attic cellulose blow was uneven but acceptable. [5]
- The furnace plenum was not air sealed or insulated. [6]

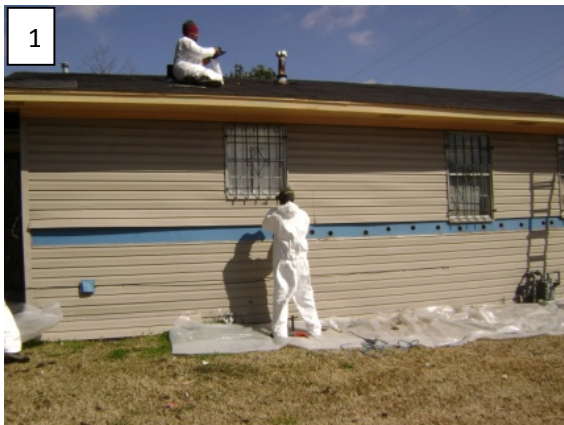
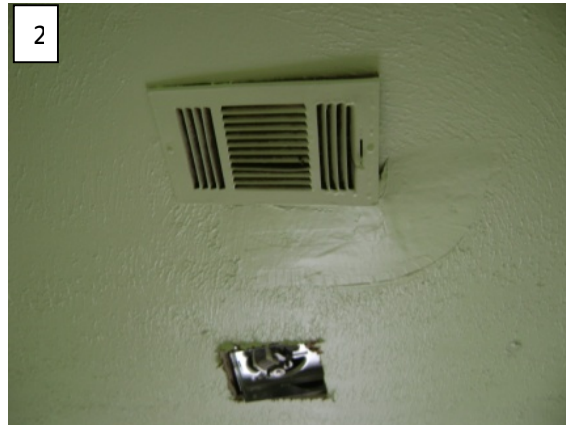
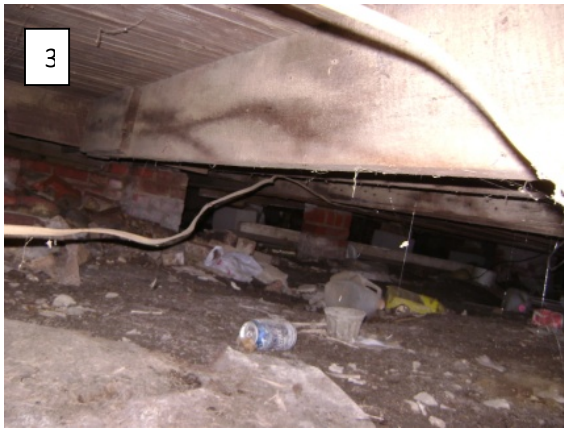
- Installer is drilling and probing the wall cavity. Concern: The installer was extremely rough with the vinyl siding; completely removing it instead of unzipping and propping up. Installer is using lead-safe practices. [1]
- Not pictured: The insertion tube used to dense blow the wall appears too short to achieve proper density at tops of cavities.
- A new bath fan is sitting in a recently cut hole. [2]
- When asked, the CAA director on site with us said poly groundcover will be installed in the crawl space, but this is not on the work order or materials list. [3]

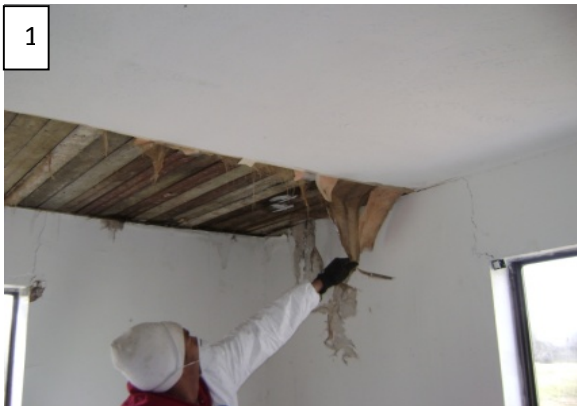
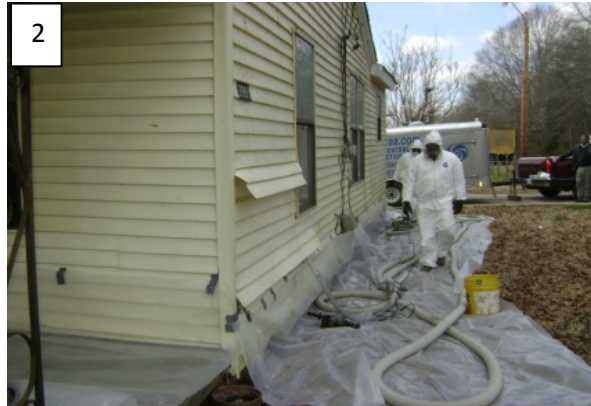
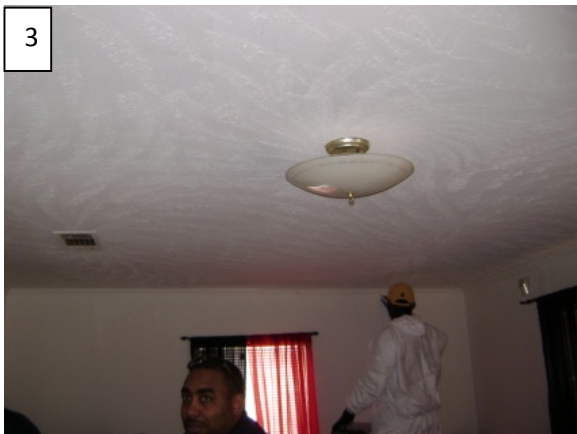
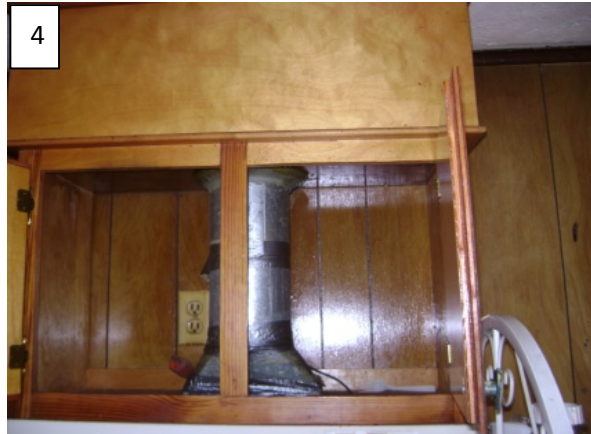
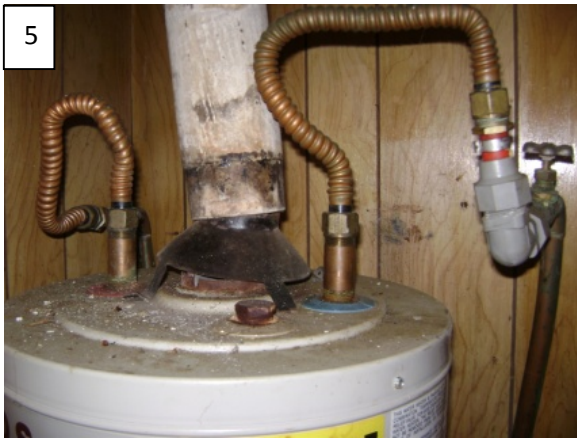
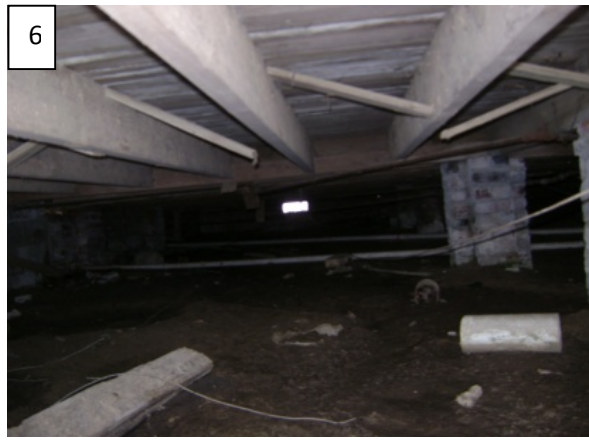
- A section of ceiling is being replaced. [1]
- The workers are prepping the wall for dense-blow cellulose. Note the siding is unzipped and propped up correctly. (See unit #7.) Good lead-safe practices were employed. [2]
- Very thorough molding caulking is underway. [3]
- The range hood is ducted to the exterior. [4]
- The gas water heater vent will be replaced. [5]
- There is no mention of groundcover on the work order for the crawl space. [6]

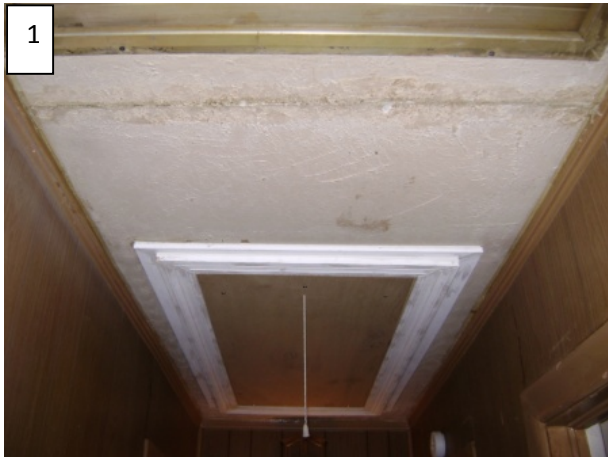
- Blower door shows that the majority of air sealing attempted was effective.
- New attic pull-down stairs were neatly installed but produce little energy savings. [1]

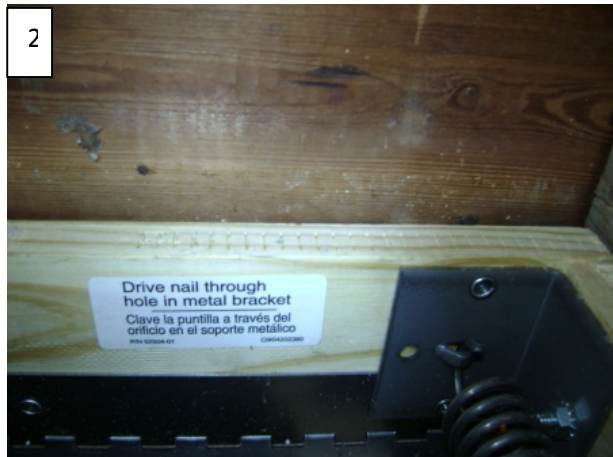
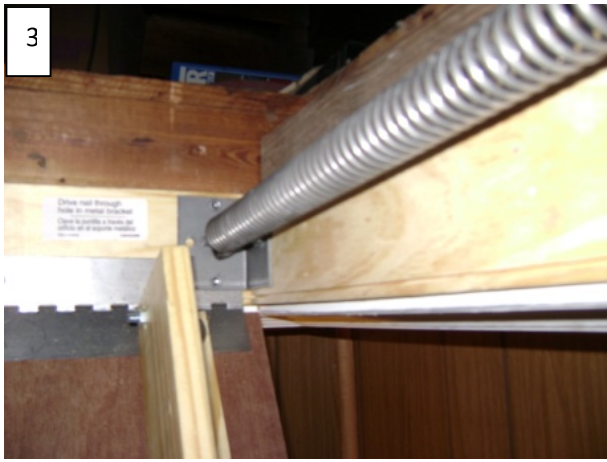
- A close-up of installation directions says nails should be installed through provided holes in spring brackets, but there are no nails and the other bracket is identical. [2] & [3]

- The pull-down cover is 1/4" plywood and has no insulation or weatherstrip. [3]
- The attic cellulose blow was somewhat uneven but acceptable. [4] & [5]

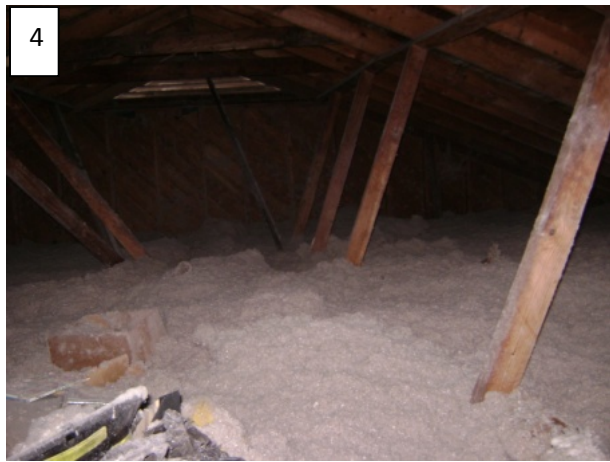
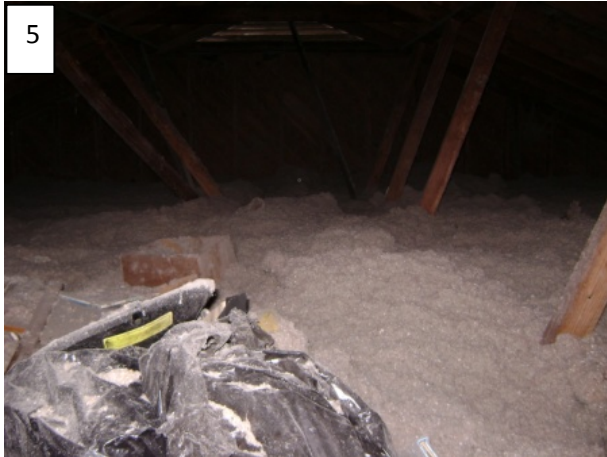
- Client items are buried in cellulose. [4] & [5]
- A new bath fan was installed behind an apparently operable existing fan. [6]
- The whole-house fan treatment (not pictured) leaked badly during the blower door test.
