# Moisture Problems in Manufactured Housing

*Manufactured homes are affordable to many. A study points the way to making them healthy by dealing with moisture problems.*

by Neil Moyer

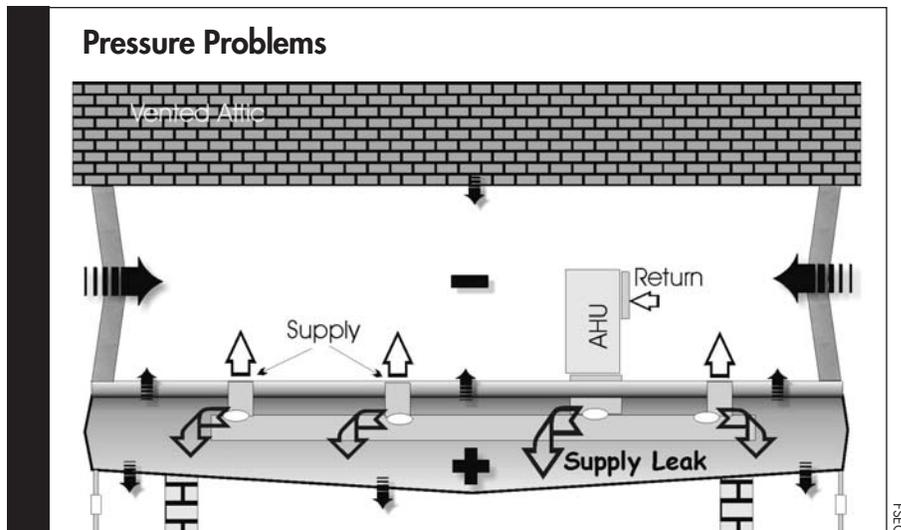
other connection points in the ductwork. When the AHU moves air through the ducts located under the floor, some of it leaks into the belly and eventually to the outside through tears in the belly board (see Figure 1). This loss of air creates a negative pressure inside the house and a positive pressure in the belly, because the return, being located in the home, has no such leakage. The negative pressure draws outside or attic air into the house through the numerous cracks and crevices connecting the inside of the house to the outside or to the attic. If this outside air is cold and dry, as it is in the winter-time in the northern United States, it will increase heating energy use and occupant discomfort. This situation will not rot a home in a northern

Figure 1. Supply leaks can cause positive pressures in the belly of manufactured homes. The resulting negative pressure in the living space can draw in moist air from the outside.

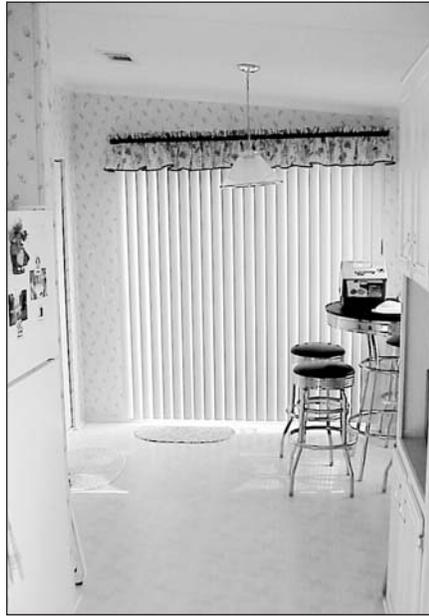
A pattern of floor moisture and staining problems appears when the duct system is located overhead, in an attic space. We found stained and warped vinyl-covered floors in areas under the ceiling registers. The areas that were being washed by cold air from the supply reg-

isters showed the worst staining. It is reasonable to assume that areas being washed by the supply air will tend to be cooler than other areas. This cooling of the floor surfaces creates temperatures below the dew point temperature of the crawlspace and condensation occurs.

This kitchen has a vinyl floor covering and an overhead supply register. Mold can occur under the vinyl that is washed by cold air from the register.

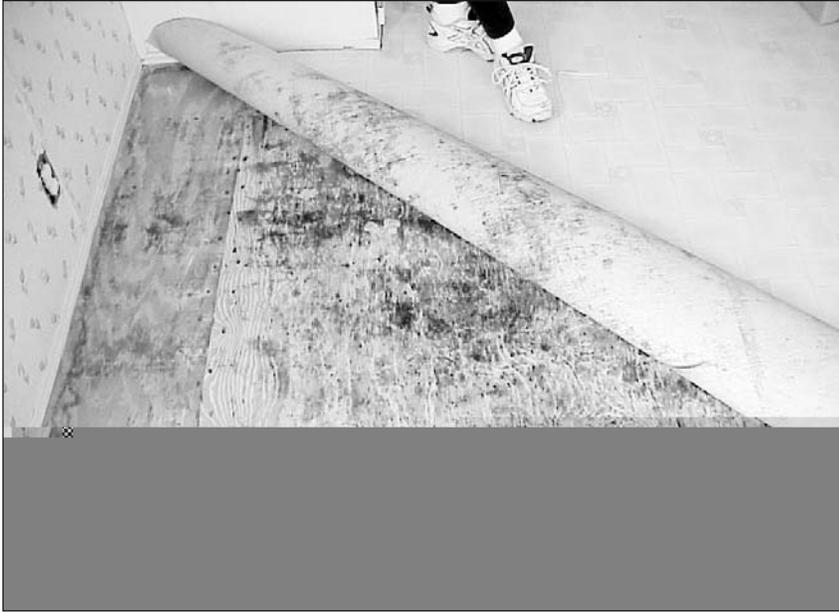
Vinyl flooring in manufactured homes can cause moisture damage, since the low moisture permeability of vinyl can lead to condensation.
