Moisture Problems in Manufactured Housing

Manufactured homes are affordable to many. A study points the way to making them healthy by dealing with moisture problems.

by Neil Moyer

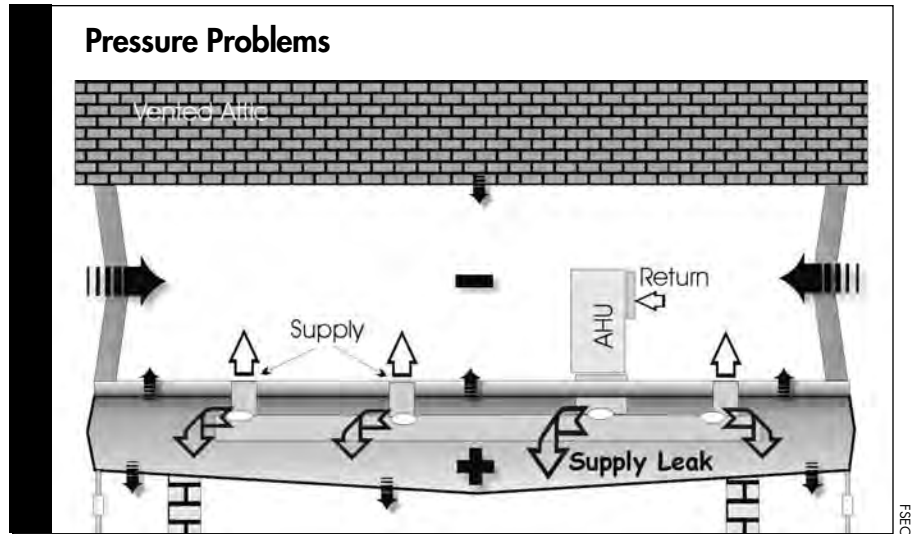
other connection points in the ductwork. When the AHU moves air through the ducts located under the floor, some of it leaks into the belly and eventually to the outside through tears in the belly board (see Figure 1). This loss of air creates a negative pressure inside the house and a positive pressure in the belly, because the return, being located in the home, has no such leakage. The negative pressure draws outside or attic air into the house through the numerous cracks and crevices connecting the inside of the house to the outside or to the attic. If this outside air is cold and dry, as it is in the winter-time in the northern United States, it will increase heating energy use and occupant discomfort. This situation will not rot a home in a northern

Figure 1. Supply leaks can cause positive pressures in the belly of manufactured homes. The resulting negative pressure in the living space can draw in moist air from the outside.

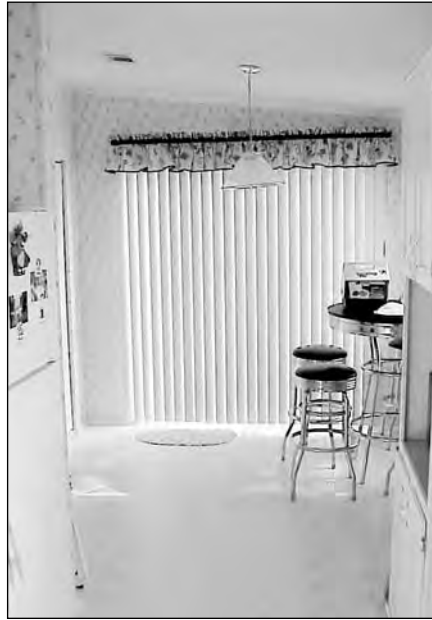
A pattern of floor moisture and staining problems appears when the duct system is located overhead, in an attic space. We found stained and warped vinyl-covered floors in areas under the ceiling registers. The areas that were being washed by cold air from the supply reg-

isters showed the worst staining. It is reasonable to assume that areas being washed by the supply air will tend to be cooler than other areas. This cooling of the floor surfaces creates temperatures below the dew point temperature of the crawlspace and condensation occurs.

This kitchen has a vinyl floor covering and an overhead supply register. Mold can occur under the vinyl that is washed by cold air from the register.

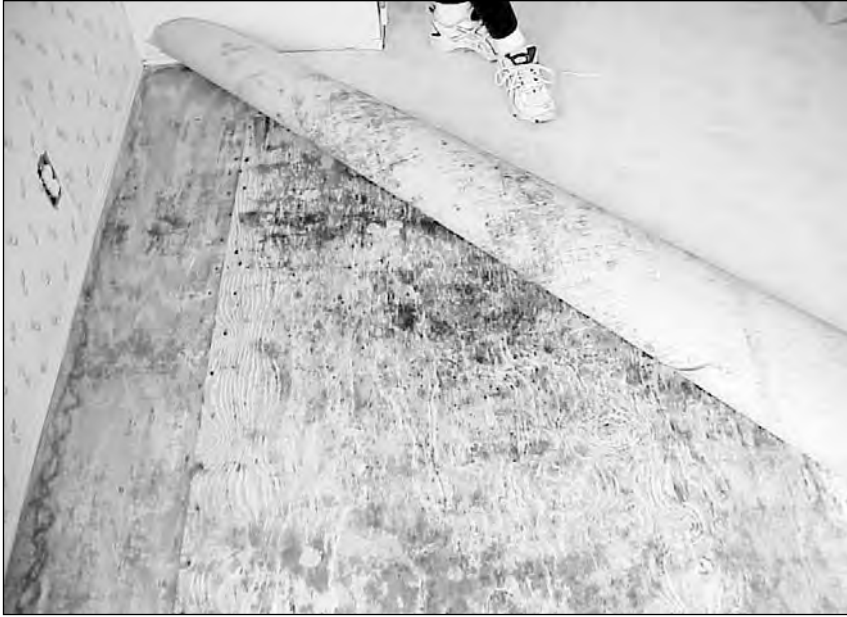
Vinyl flooring in manufactured homes can cause moisture damage, since the low moisture permeability of vinyl can lead to condensation.
