WEATHERIZATION ENERGY AUDITOR SINGLE FAMILY

# Audit Process

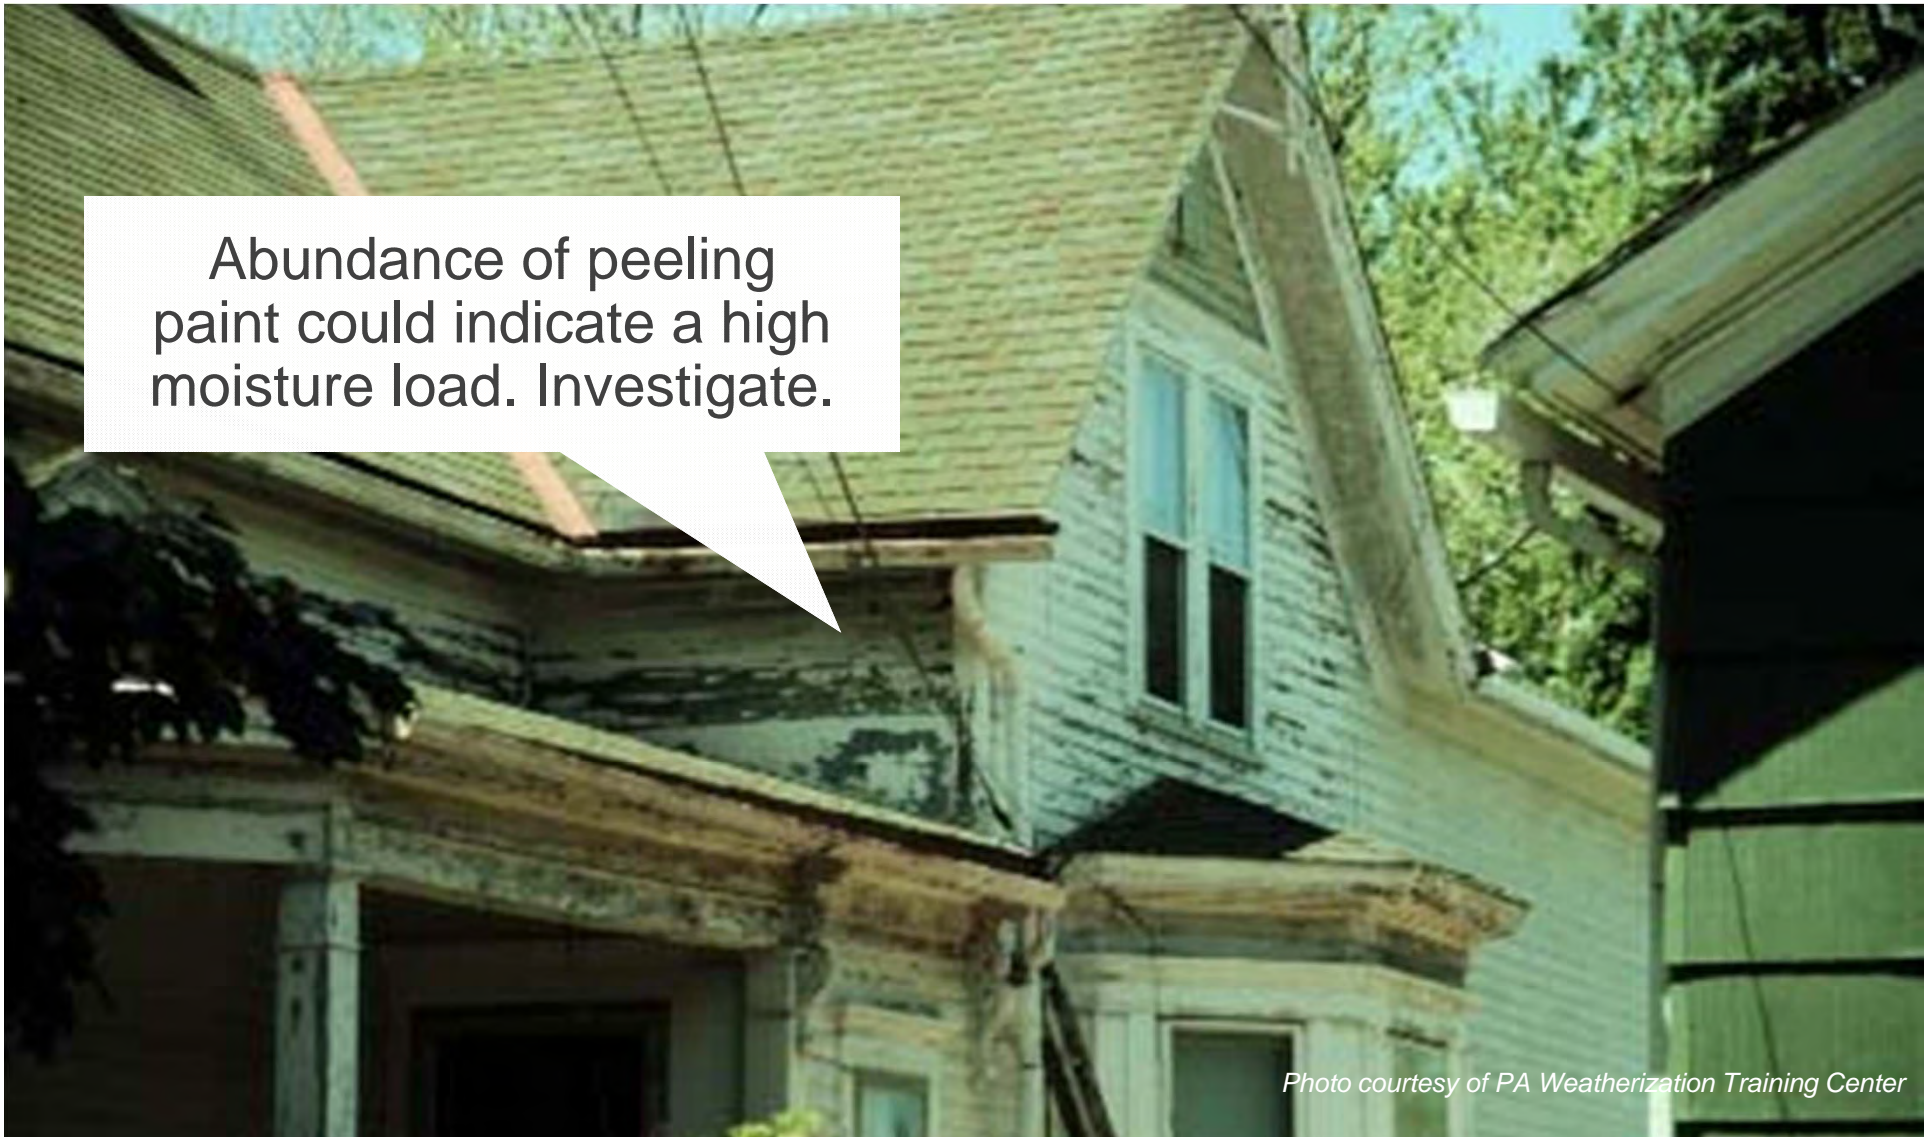
Abundance of peeling paint could indicate a high moisture load. Investigate.

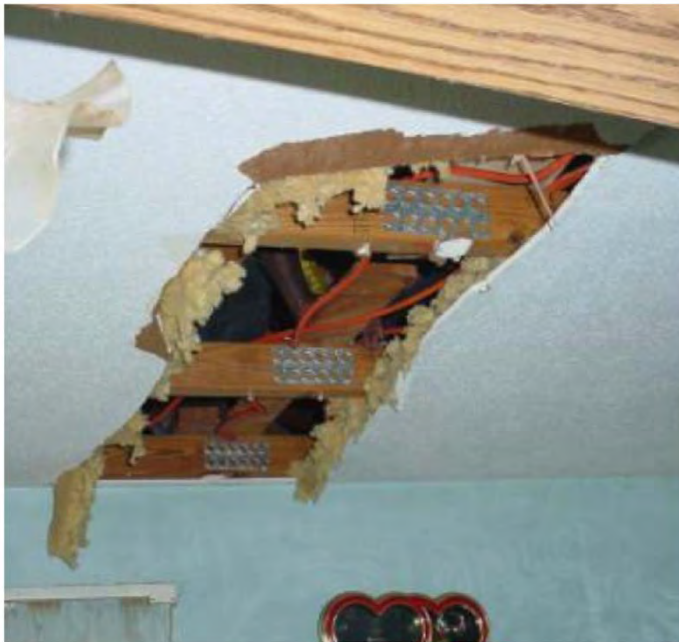
Damaged ceilings may indicate moisture issues.

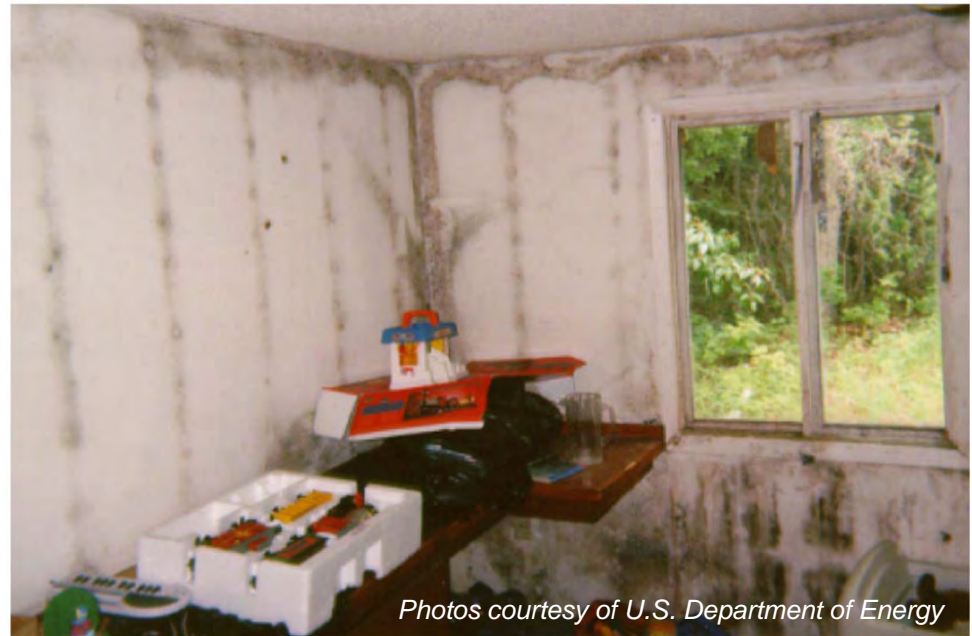
Mold on walls indicates serious moisture issues in the home. Determine underlying causes and mitigate before *any* air sealing.

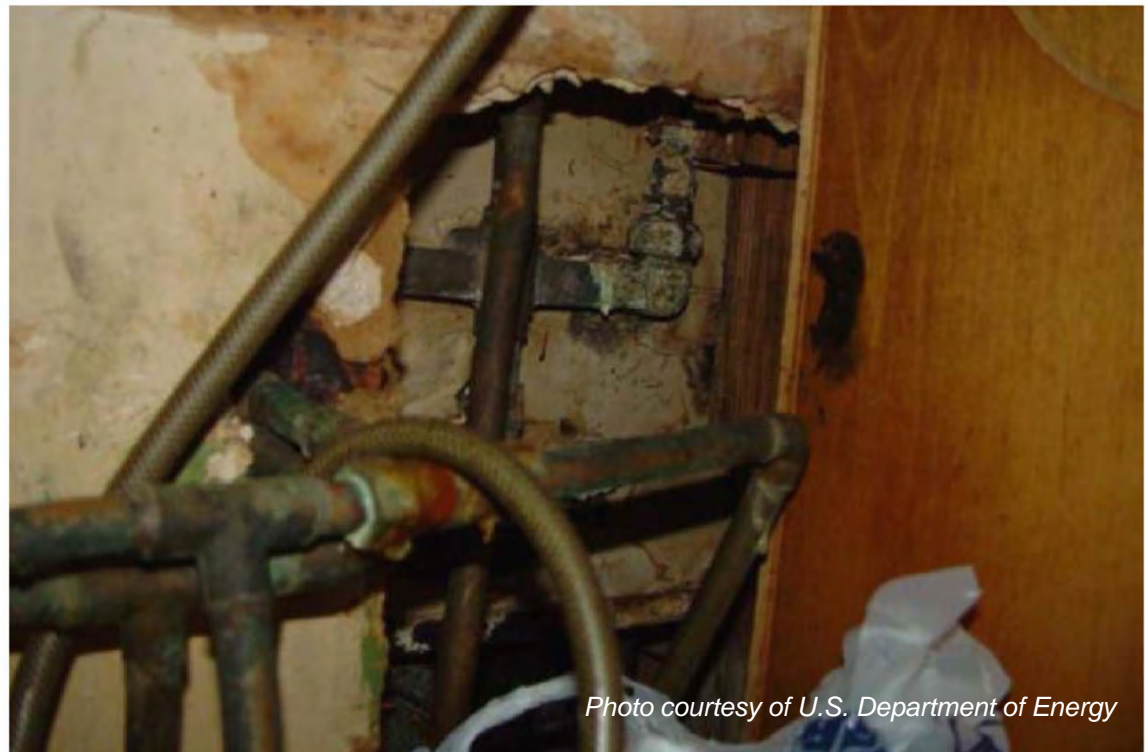
- This opening within the plumbing wall was discovered behind an access door.
- The opening is a major source of air leakage.

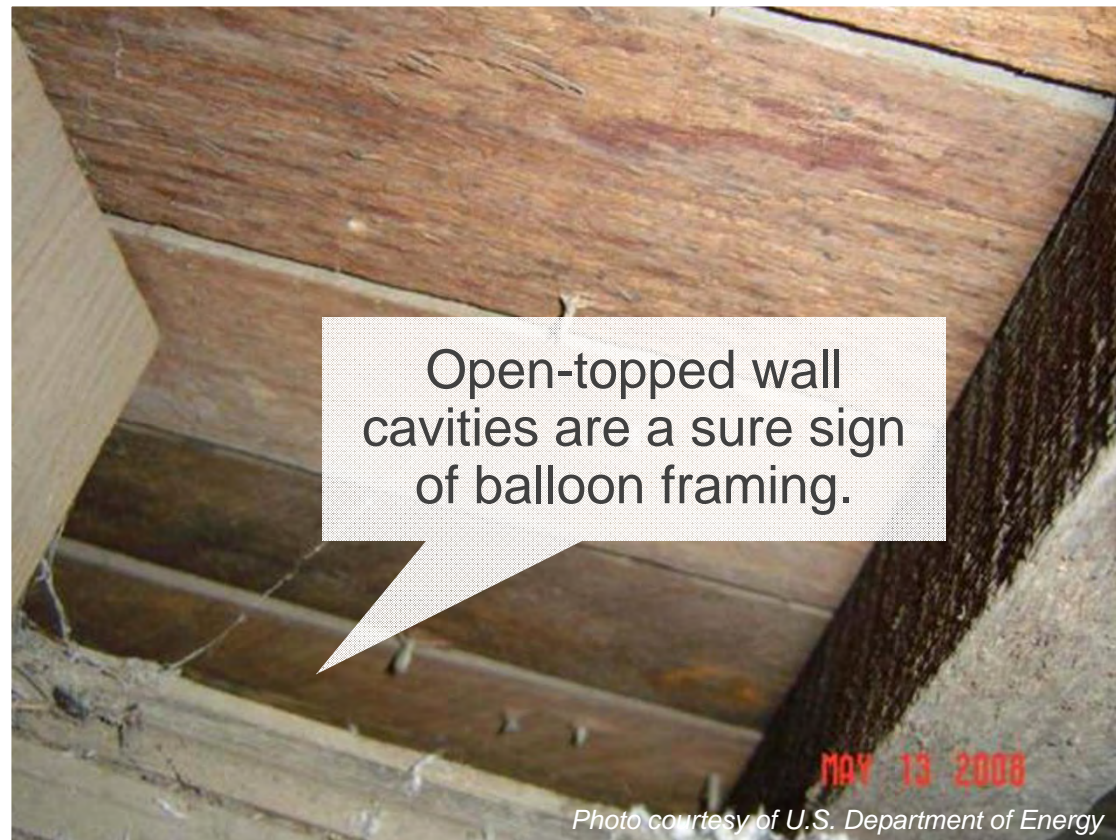
- From the attic, framing style is often evident.
- Top plates indicate platform framing.

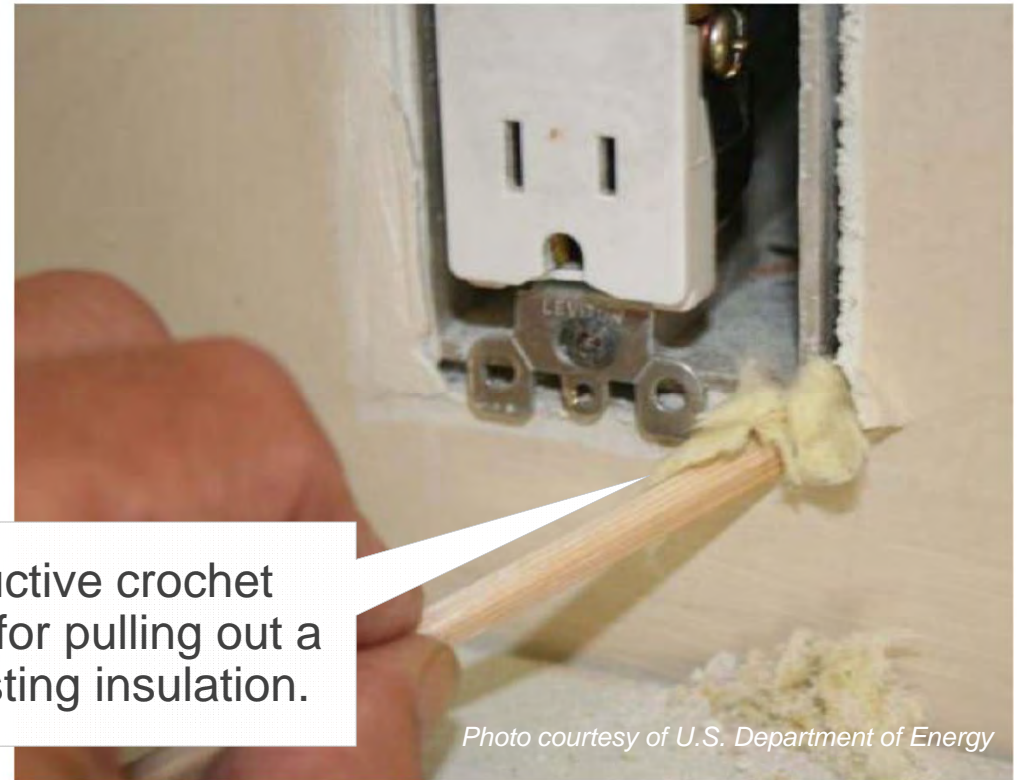
A non-conductive crochet hook is handy for pulling out a sample of existing insulation.

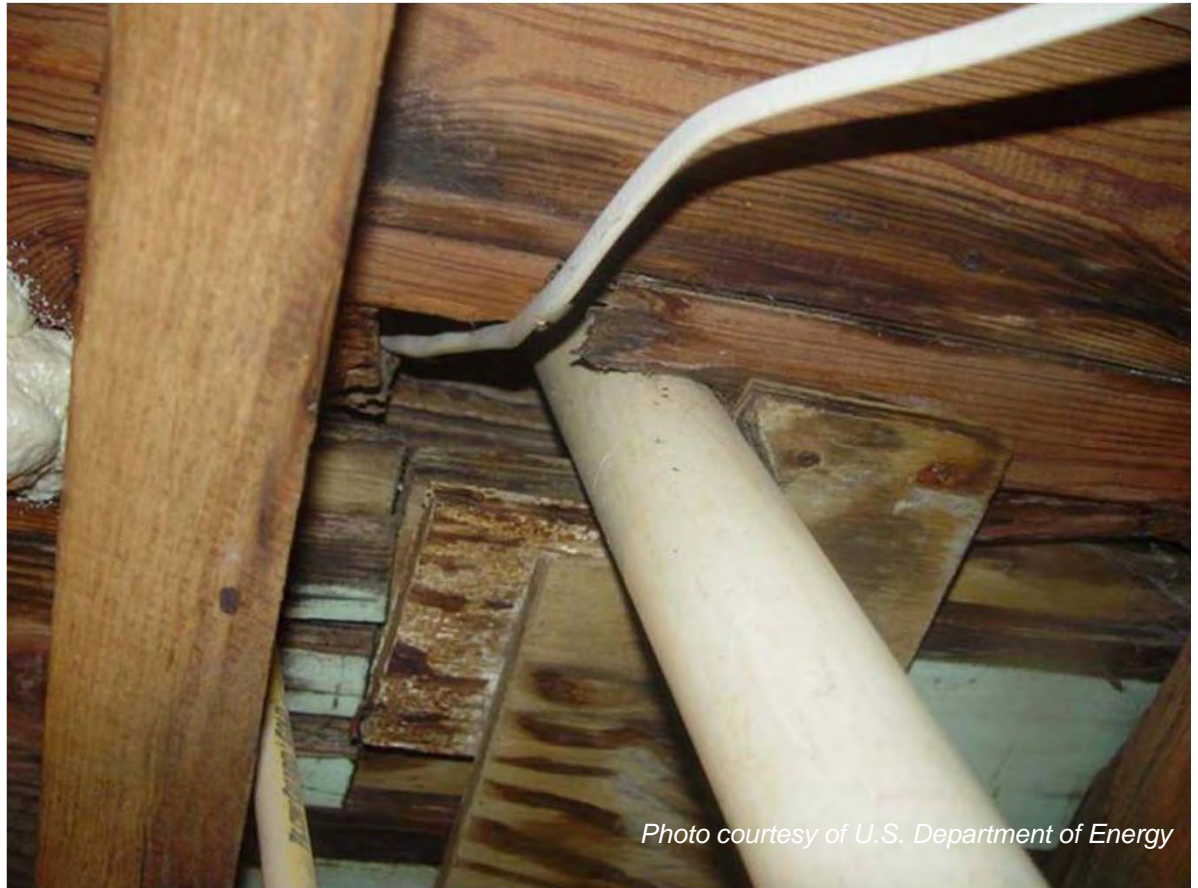
- Note major air leakage sites on sketch.
- Plumbing and wiring penetrations are common air leakage sites.

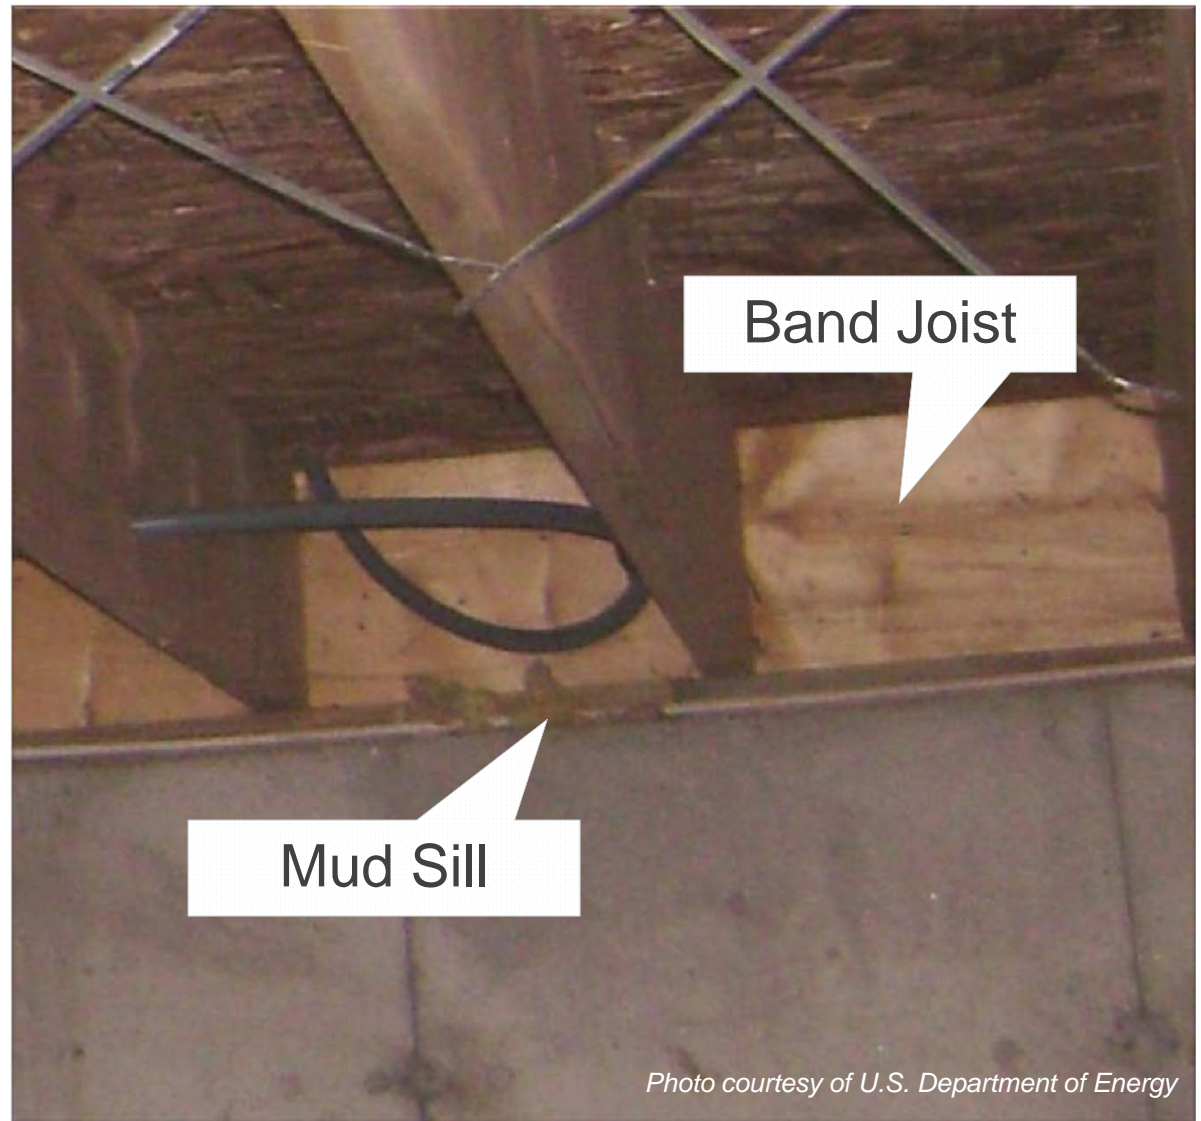
- Note ceiling, wall and band joist insulation levels.
- This box sill is a common perimeter leakage site in basements.

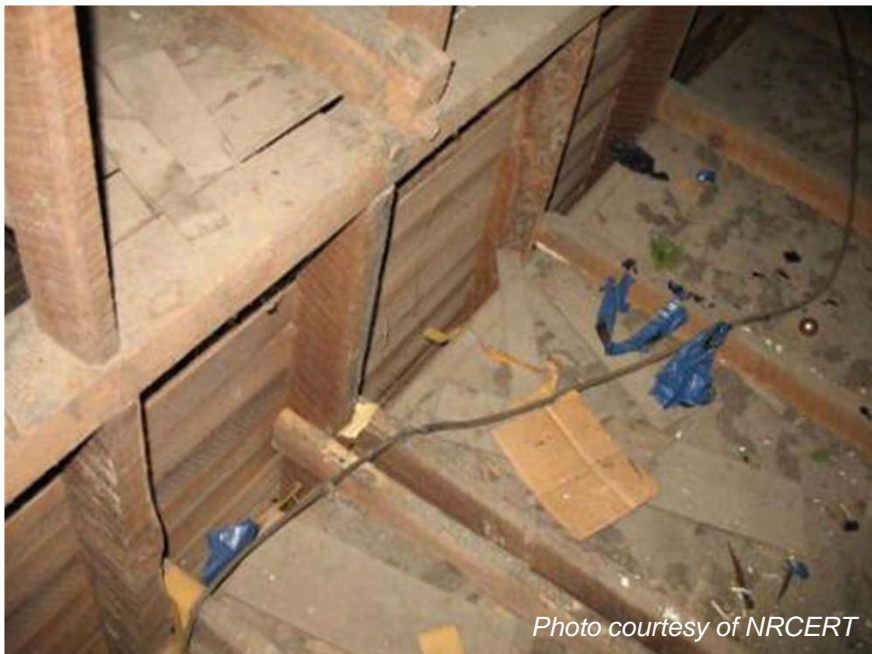
Open wall cavities

The interior wall cavity acts as a chimney that robs the house of heat and conditioned air.

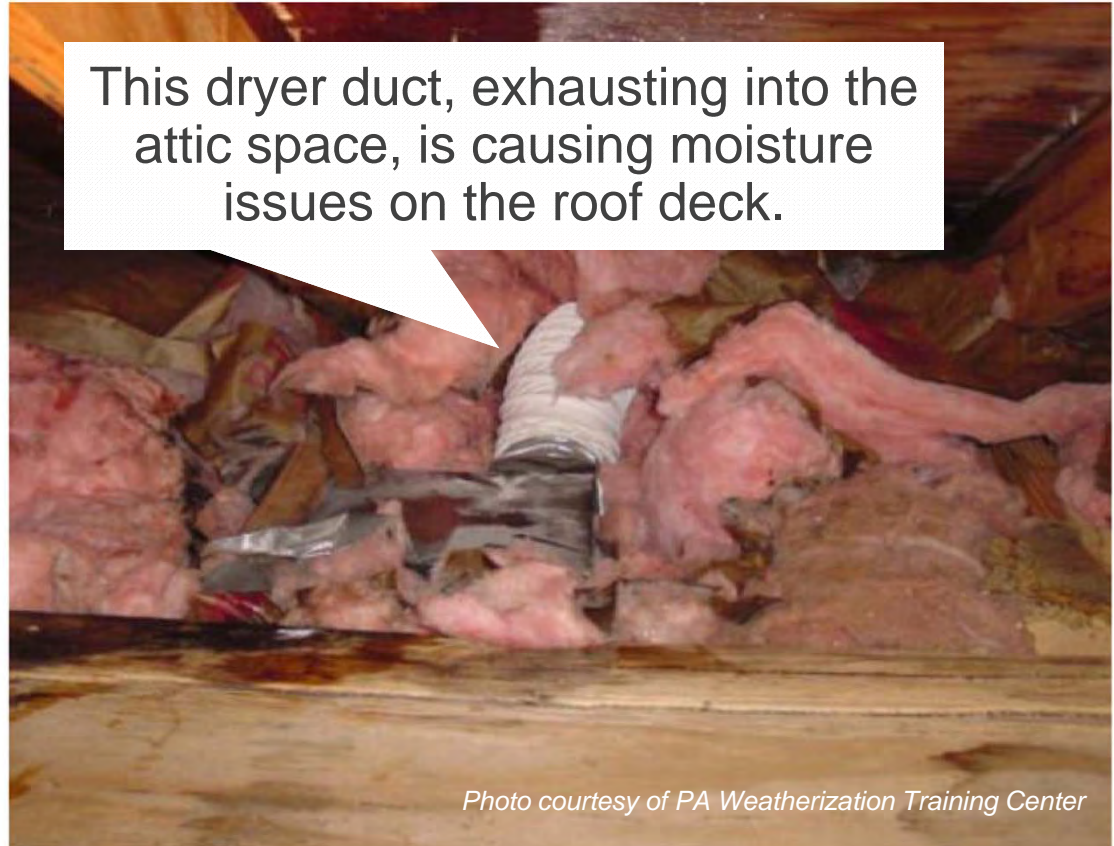
This dryer duct, exhausting into the attic space, is causing moisture issues on the roof deck.

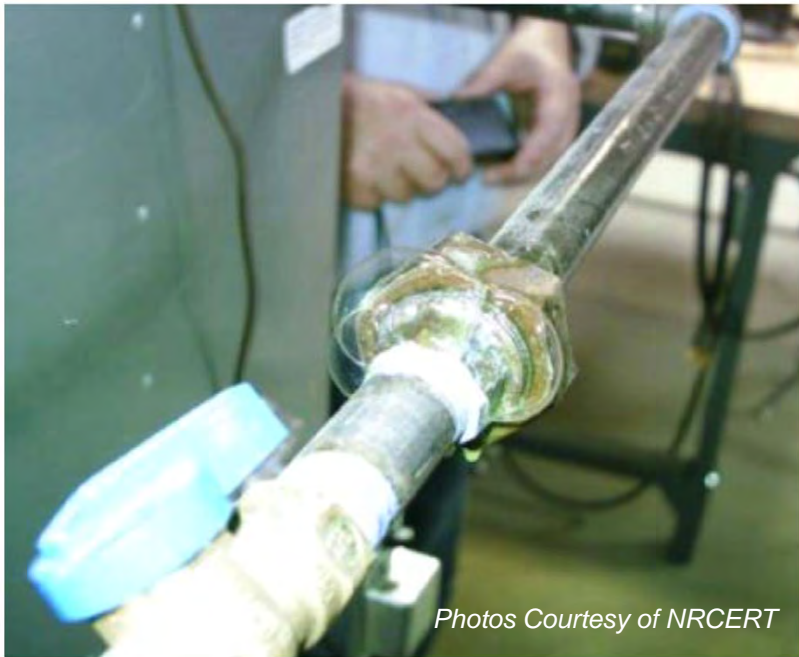
Gas leak detector for  
gas and propane.

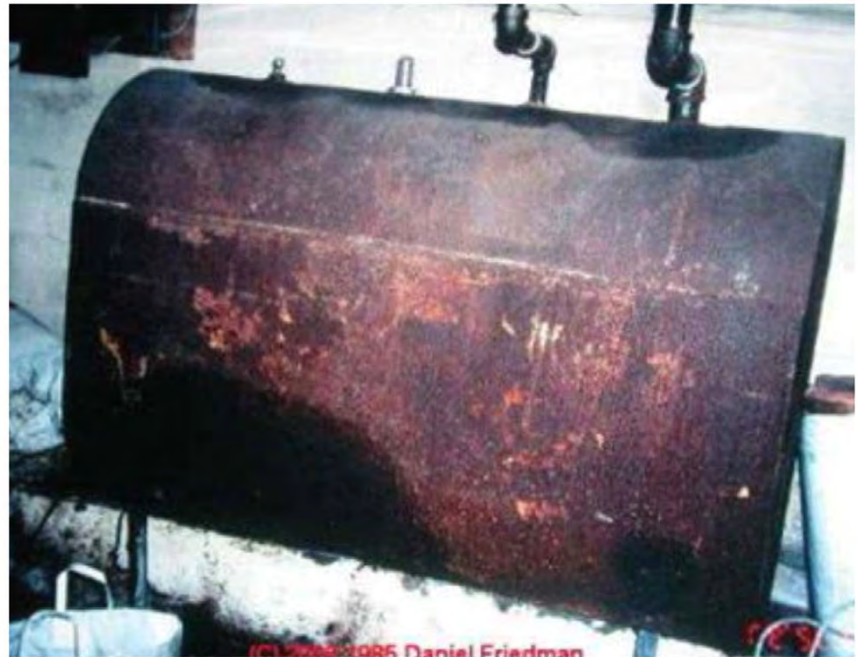
Visual inspection and the  
personal sniff test for fuel oil.

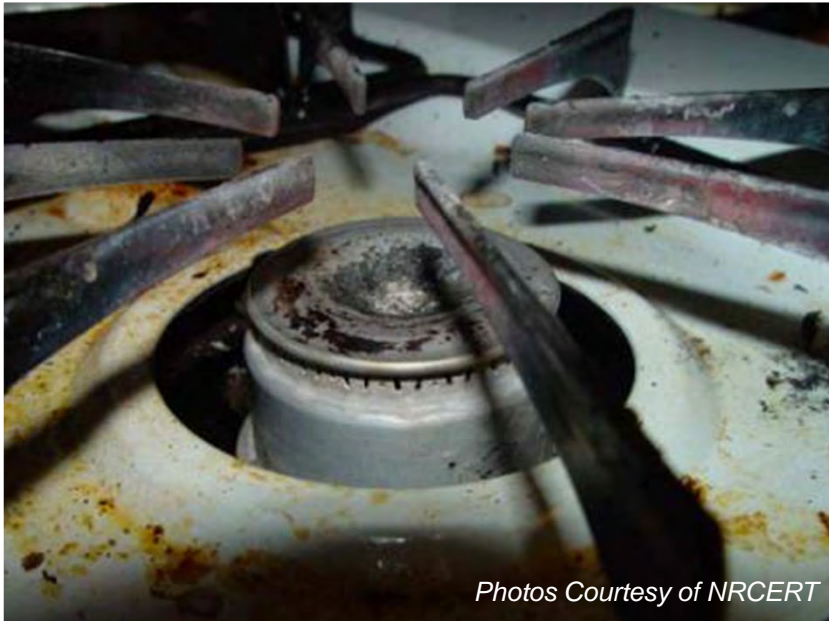
Test each range top burner for CO.  
Hold probe 6" above flame and  
measure the CO content in  
ambient air.

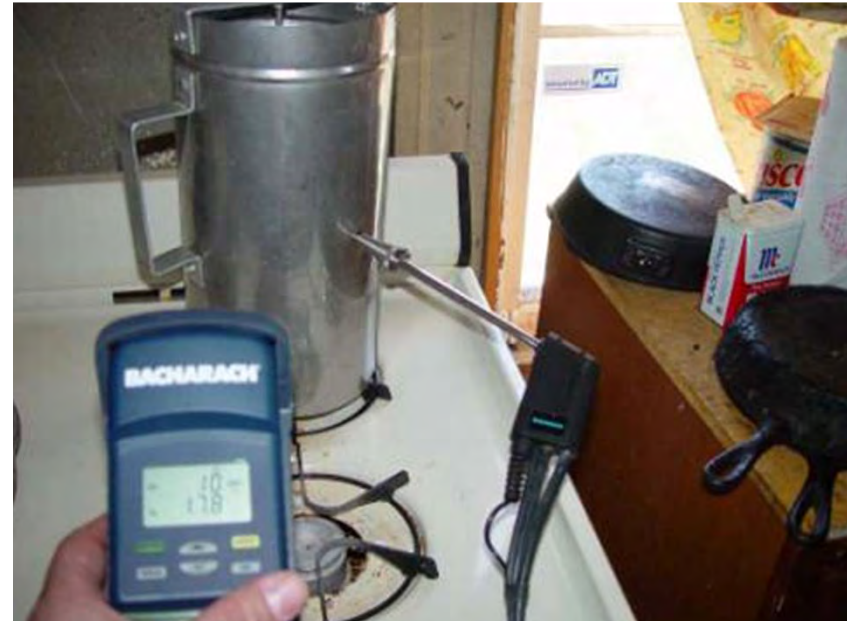
A portable flue section concentrates  
combustion byproducts for an  
accurate CO measurement.

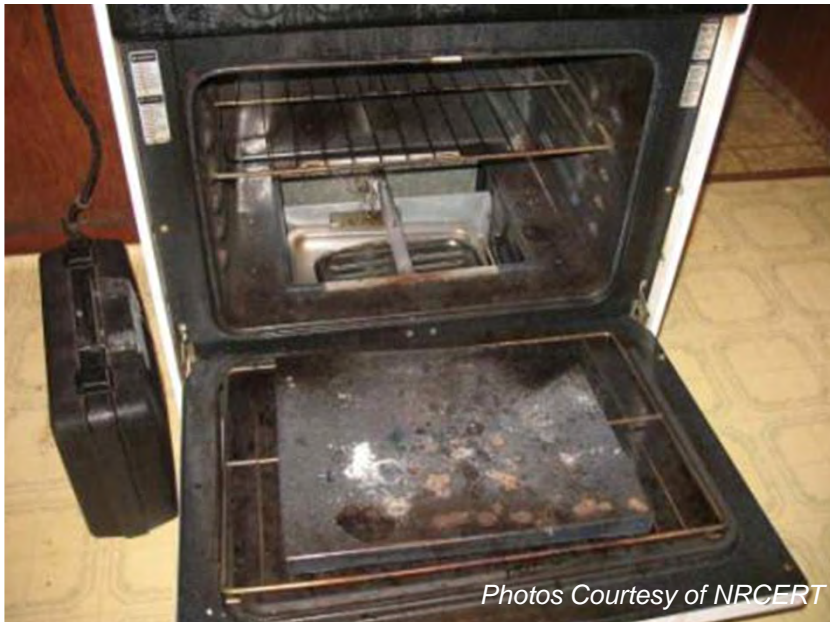
Prepare the oven for a test by removing stored items, aluminum foil, etc.

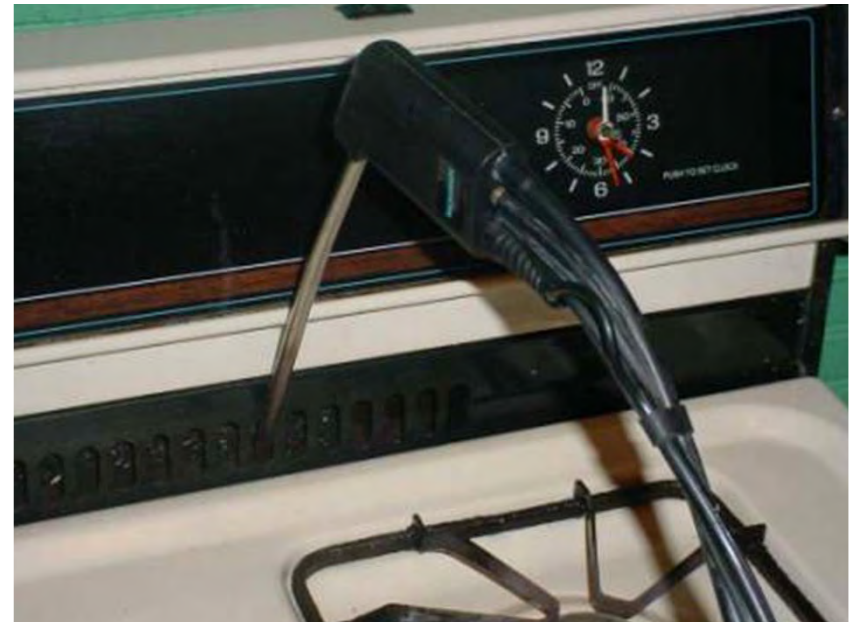
Insert the probe of the analyzer into the oven vent and read the CO content after the oven has warmed.

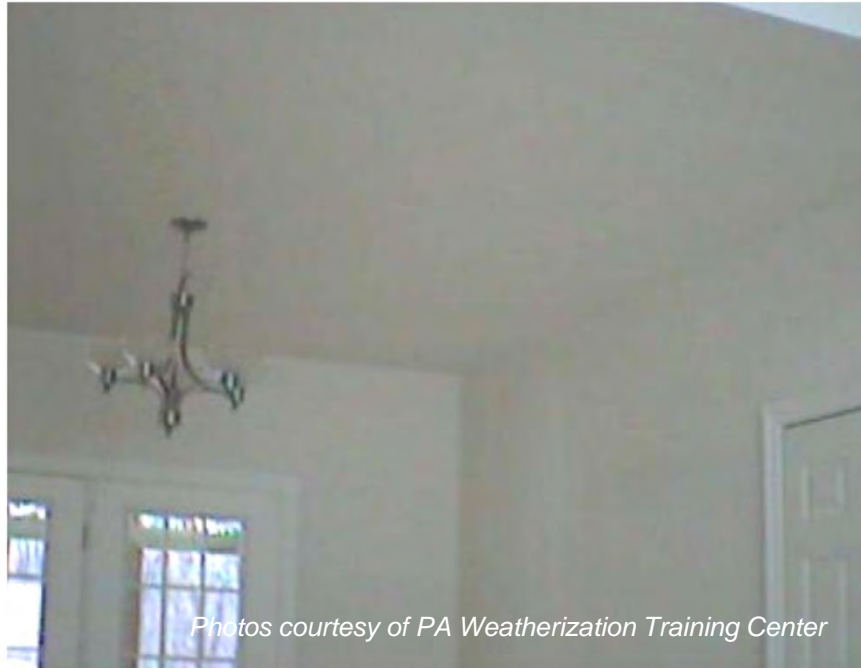
A visible image of a ceiling detail between the first and second story.

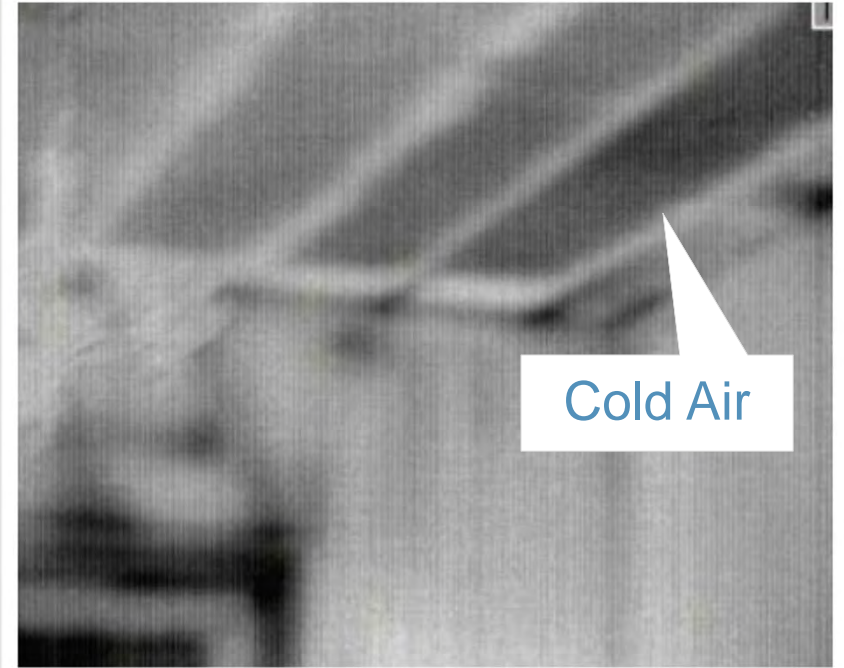
An infrared scan of the same area with the blower door running shows air leakage in the ceiling joist cavities.

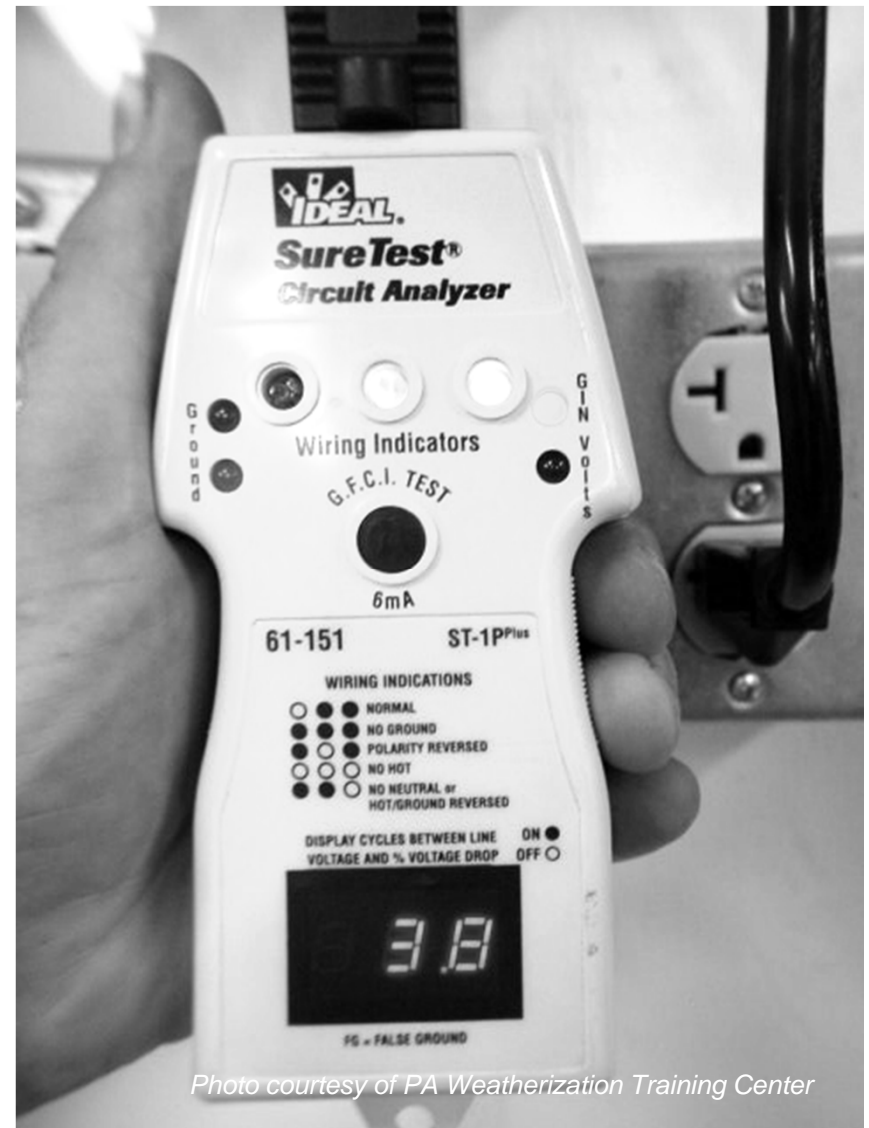
- Reads the percentage of voltage drop on a circuit.
- A difference above 5% may indicate an unsafe condition.
- A qualified technician should investigate potential wiring problems.

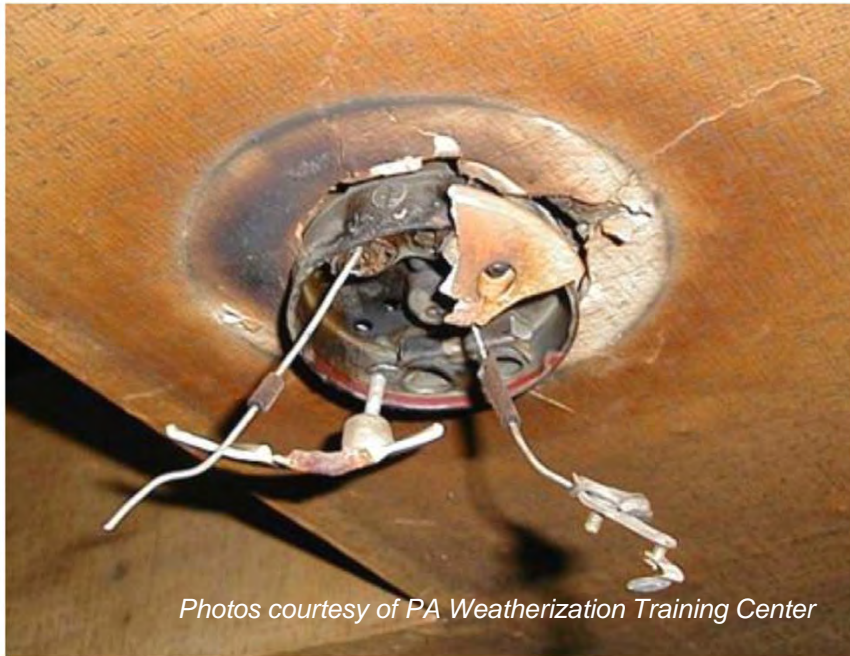
Charring on the light fixture and ceiling is evidence of a degraded wiring connection.

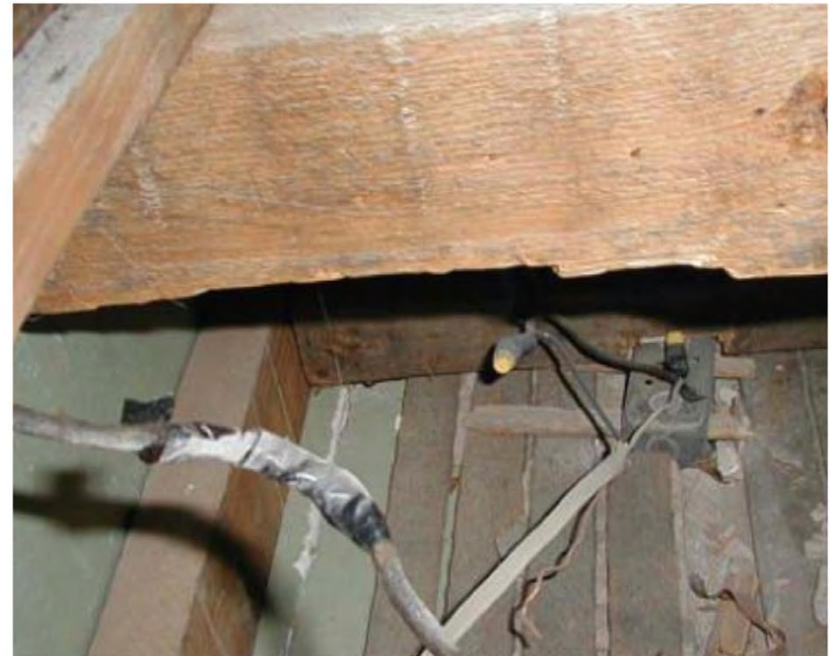
Taped and uncovered wiring splices such as these are unsafe and must never be covered with insulation.

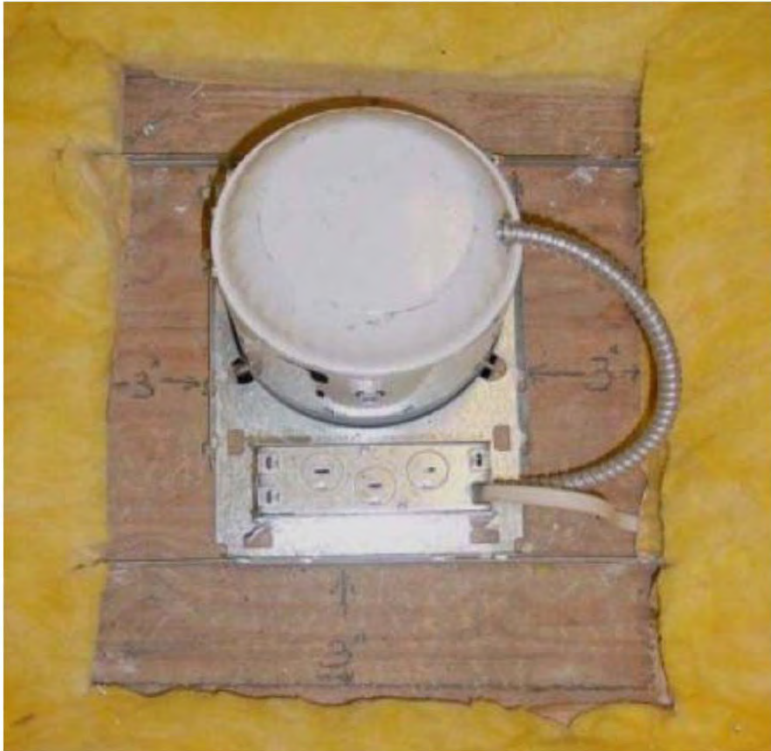
Provide 3" of air space between recessed lights and insulation or other flammables.
