Retrofitting Residential HVAC Systems

In this case study, we show how DOE's Best Practices Guide For Residential HVAC Retrofits works—as well as some of the installation practice and building code official problems that can arise.

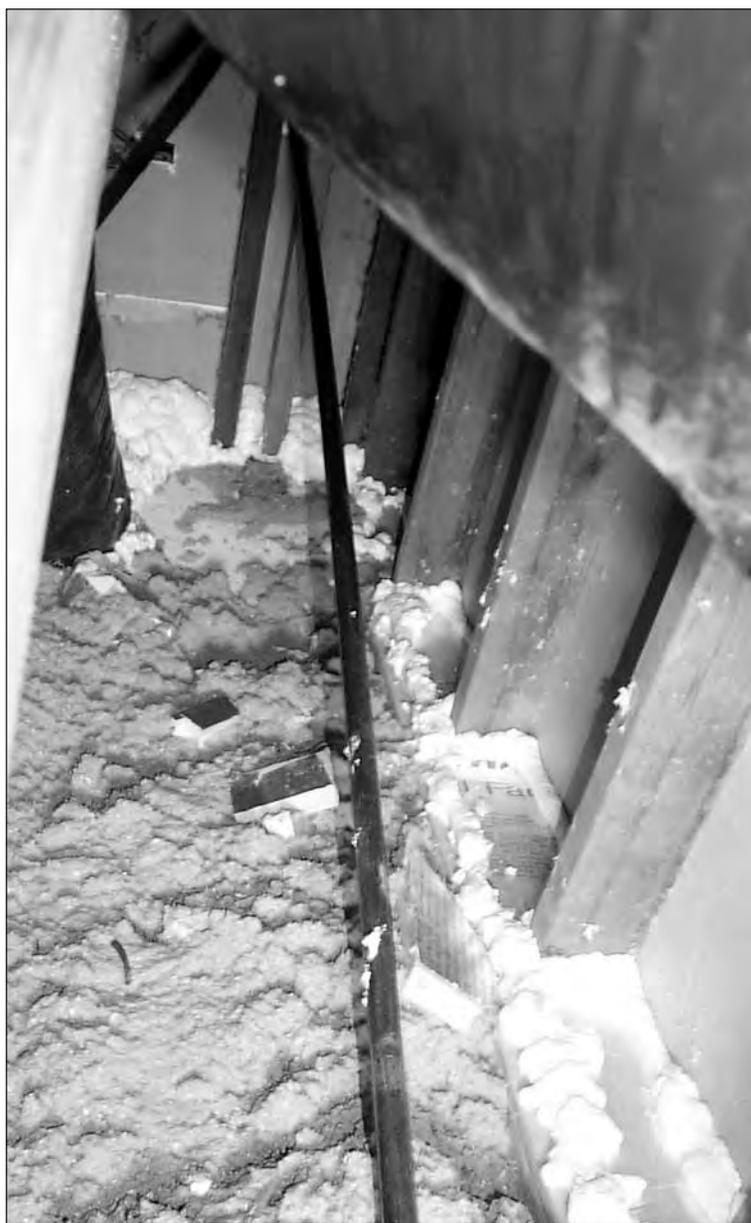
It's important to seal cavities connecting the house to the attic. Foam was used for sealing small holes and cracks at building component intersections.

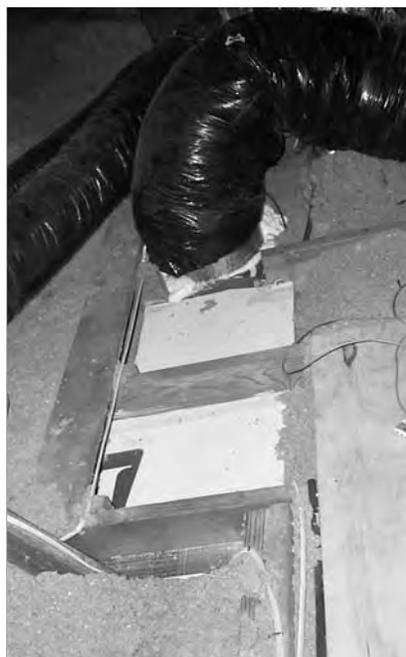
Duct board insulation was used to block off large open areas.

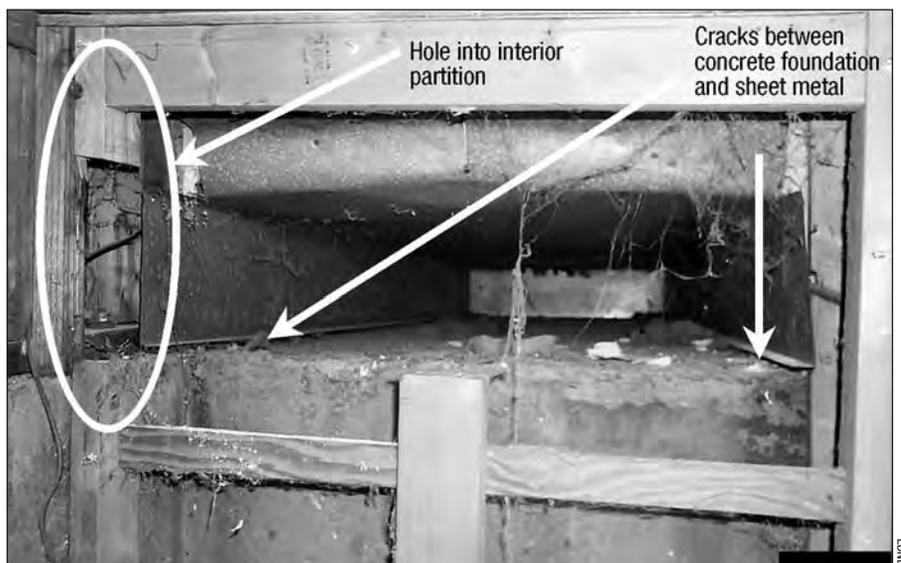
This very leaky building cavity return was removed during the retrofit.

The existing return was closed off, because it was very leaky and there was no reasonable way to seal it. A larger upstairs return was installed in a new location (upstairs hallway ceiling) to help reduce temperature stratification, and a second downstairs return was installed in a new location (in the wall at the stairway landing).

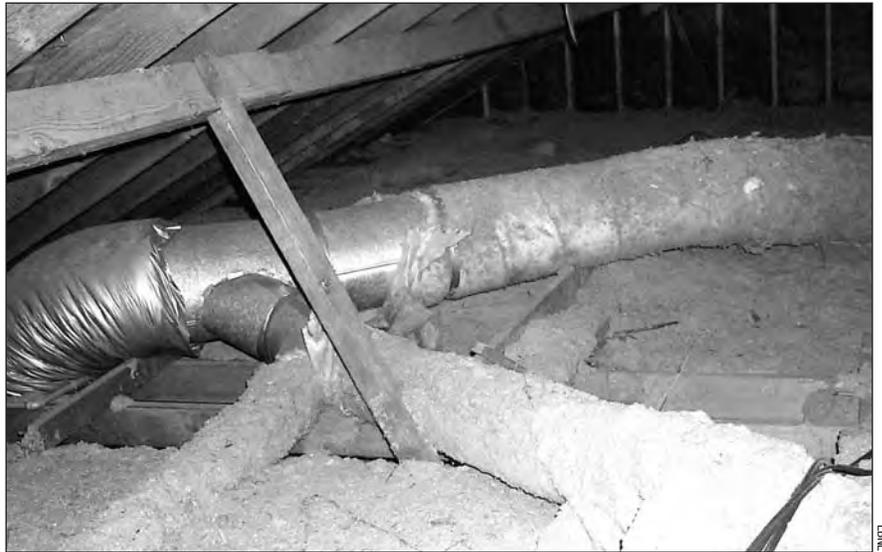
Here we see the poorly insulated sheet metal ducts and blown-in insulation in the attic before the retrofit.

- The metal ducts in the attic were replaced with new R-4 flexible ducts (despite clear and repeated instruction to retain the original ducts) because the contractor thought the original ducts were undersized. Initially the contractor hung the flex-ducts from the attic ceiling with smooth bends. However, since the ducts would be covered with insulation, the contractor placed the new ducts on the floor, but

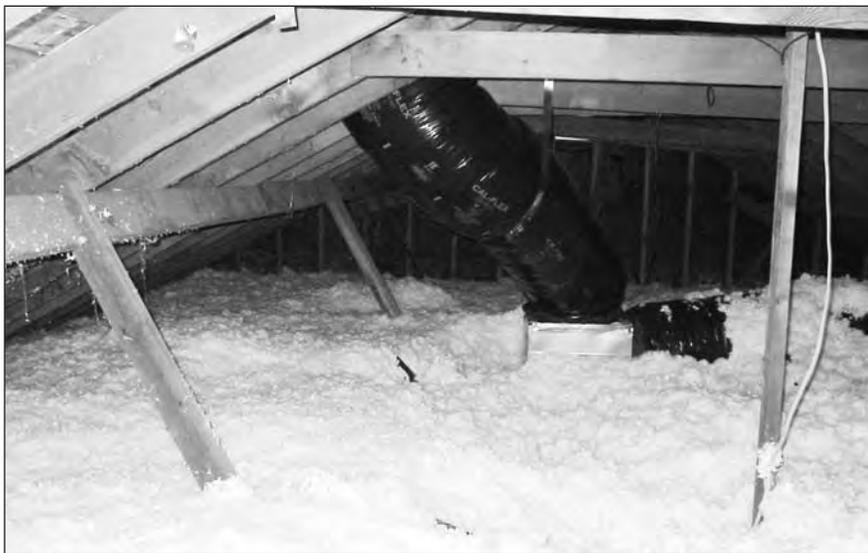
unfortunately did not take the time to lay the ducts with smooth bends. The use of flex duct increased the system air flow resistance (that contributes to noise, extra air handler power

consumption, and possibly too low a flow through the furnace and air conditioner). This problem was made worse by the many extra bends in the flex duct due to poor layout.

The new flex ducts in the attic are covered by additional blown-in insulation after the retrofit.
