**2009 NATIONAL WEATHERIZATION TRAINING CONFERENCE**  
 JULY 20-23, 2009 | INDIANAPOLIS, INDIANA

**Basic Mold and Moisture**

Russell W. Glasgow  
 State of Michigan, Technical Weatherization

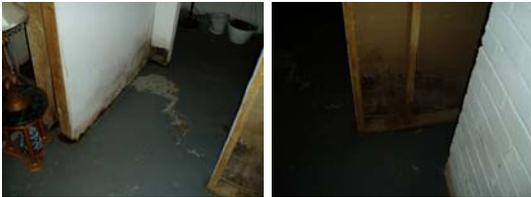
Semi finished room in basement

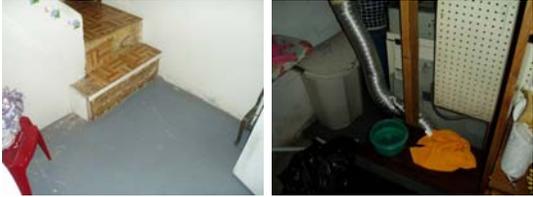
Additional signs of moisture

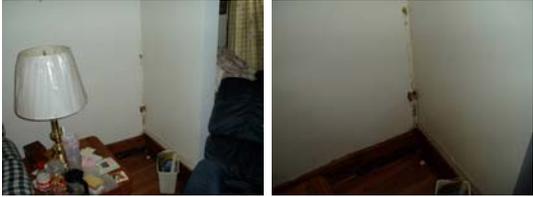
Fungus in the form of "Mushrooms" growing on wall

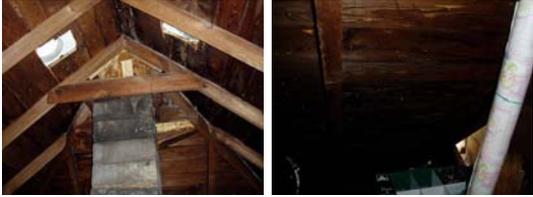
Client had a new roof installed and told the contractor  
"I have a PVC vented furnace and water heater, I don't want anything going through the roof to leak."

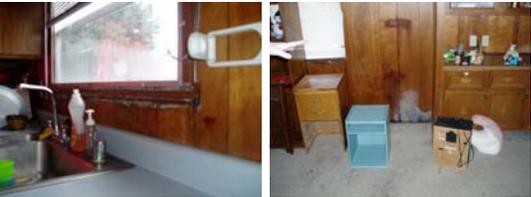
Mold on window sill from condensation on glass and mold at living room floor.

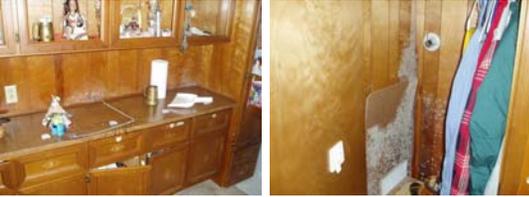
Mold above built in cabinet and coat closet on exterior wall

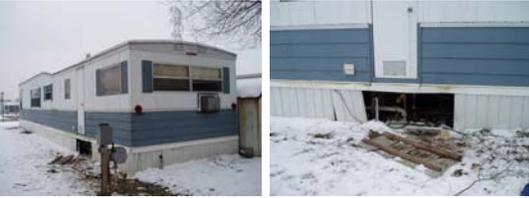
Back of manufactured home showing green grass and ice under leaking water heater

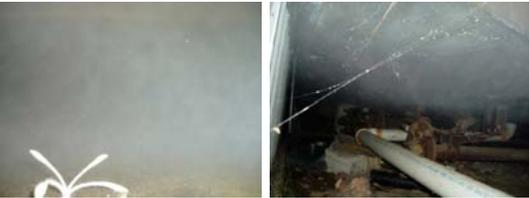
Picture under home showing "steam" from broken hot water line. Client forgot to mention she set the thermostat as low as it would go for about a week while she was gone. She did notice the leak in the water heater area.

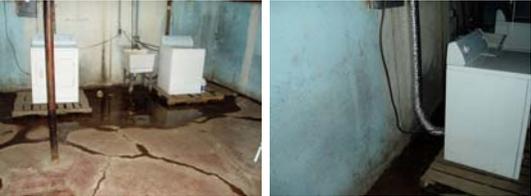
Foundation seepage bad enough to have laundry on pallets

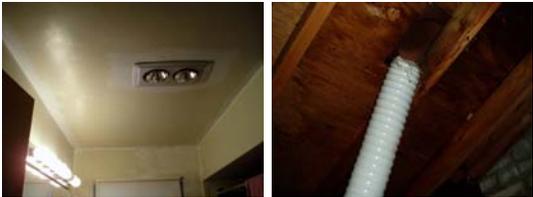
Client had "Handyman" boyfriend install a combo light/fan fixture in the bath ceiling. He just hung the end next to an existing can vent

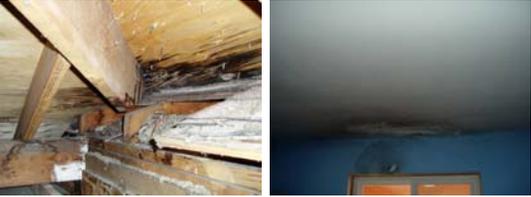
This shows the garage wall intersect about 3 feet from the vent and the bedroom ceiling next to the bath.

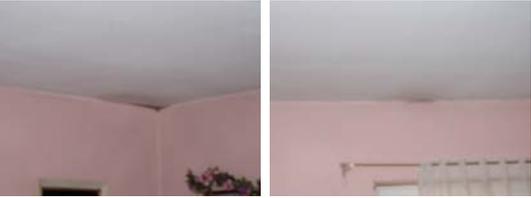
These are photos of the bedroom on the far side of the home.  
NOTE: home had hydronic baseboard heat (minimal air flow)

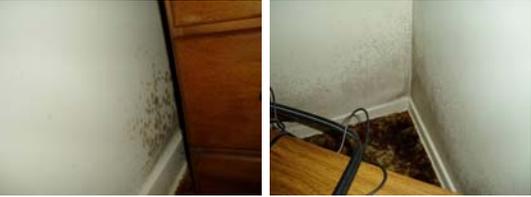
There were nice, flowering mold colonies in every room where furniture or closets limited air flow.

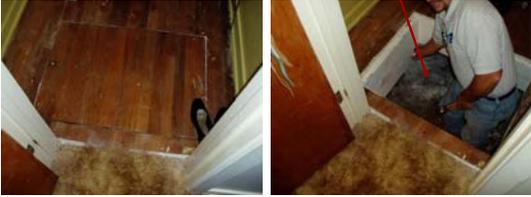
Crawlspace access was from interior closet. The client spread some lime on the ground because of the "Musty" smell

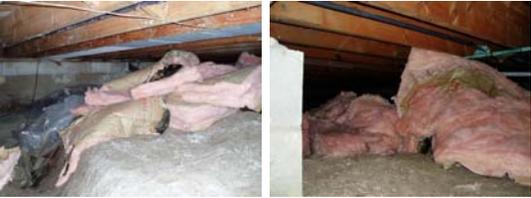
The client had removed fiberglass perimeter insulation and the ground cover because they were trapping moisture. Note that the Kraft paper is the nutrient for growth.

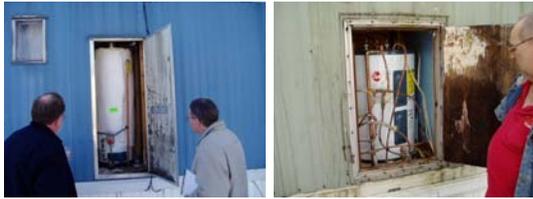
Water heater closets pose a problem even when vented especially if there are water leaks

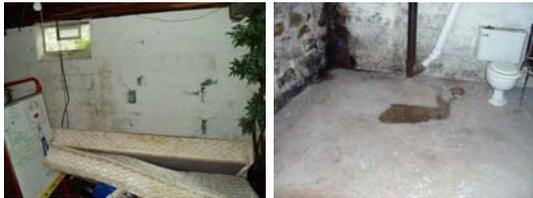
Basements are prime areas for mold because of high humidity, cold surfaces for condensation, and poor air circulation.

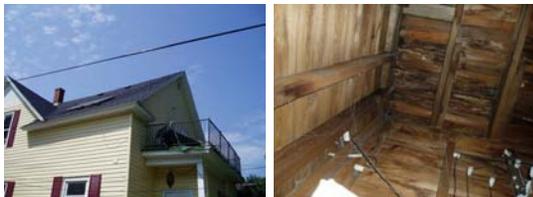
Note the flat roof above back room and then look at the ceiling of the storage area beneath it.

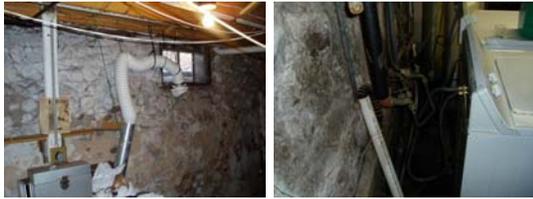
Is the problem the improperly vented dryer or the leaking clothes washer?

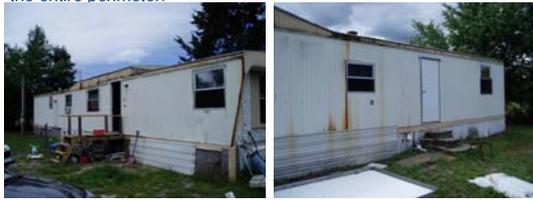
This manufactured home has had so much condensation on the bottom side of the metal roof that the wall/ceiling intersect is rotted the entire perimeter.

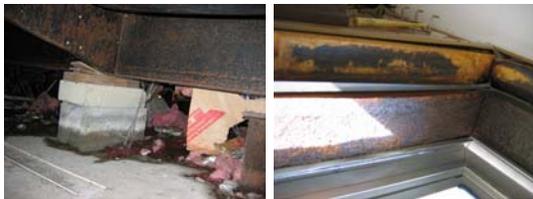
This is the belly of a manufactured home with a plumbing leak and the front door jamb showing condensation problems.

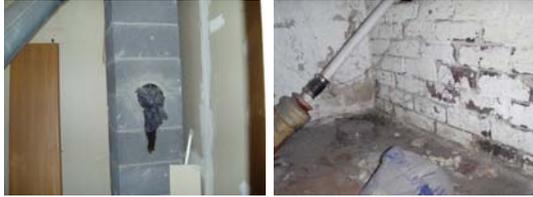
Are these signs of mold? Yes, I know the first is a creosote trail from a disconnected wood stove...but I like the picture.

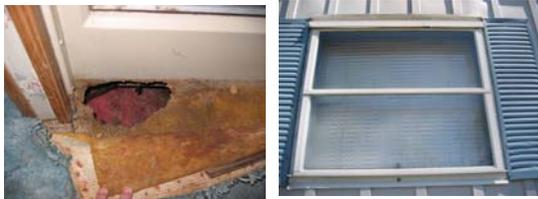
The client advised us to "take a giant step when entering" so as not to exacerbate the hole in the floor. The windows also showed condensation moisture. She would not allow me to photo the garden she had inside.

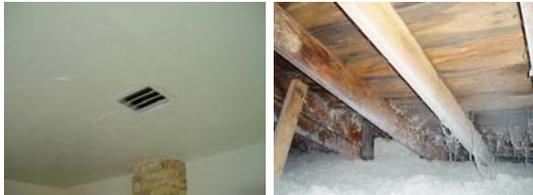
This client wanted "fresh" air into his bedroom without wasting all the heating dollars from opening a window. Too bad he did not realize he was promoting roof deck condensation.

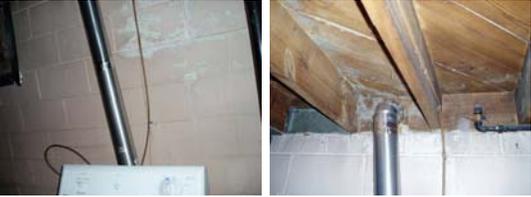
This client originally had an inline diverter to keep all that heat from going outside while drying cloths.

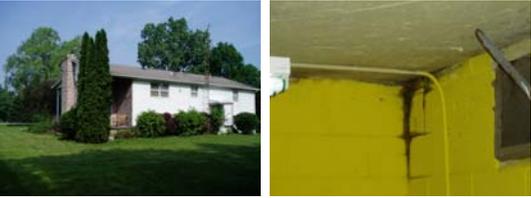
The porch in the lower corner was the ceiling for the laundry room in the basement.

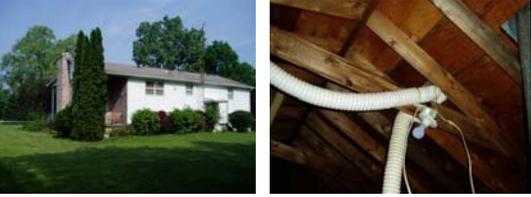
On the same house, the bath and kitchen fans terminated near an existing can vent. There was not more damage because the client never use the fans and was not sure if they worked.

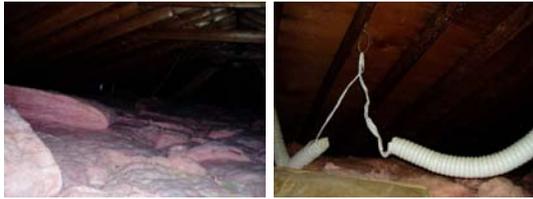
This client could not understand why he had to sign a mold waiver for his attic. He ran the duct to the cornice vent himself.

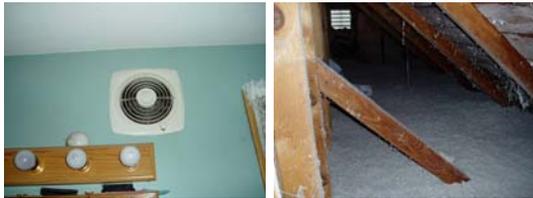
The OCJ is exterior space, right?

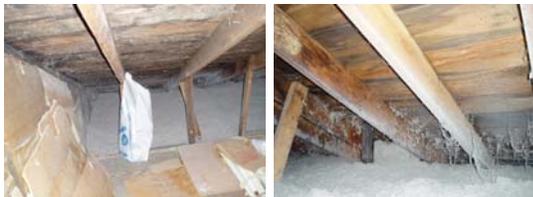
The insulation contractor failed to locate the major bypass because the attic was partially floored for storage.

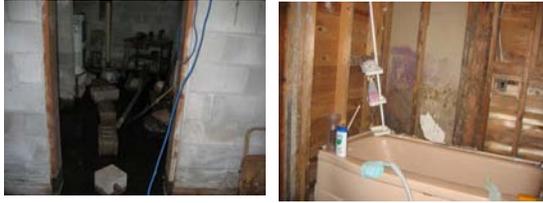
I hope I never have to relight the pilot on this water heater and the drywall was falling down around this tub so the client took it down.
