## **Sample Report**

**Site Visits**  
**Any Capitol, Any State**  
**Date**

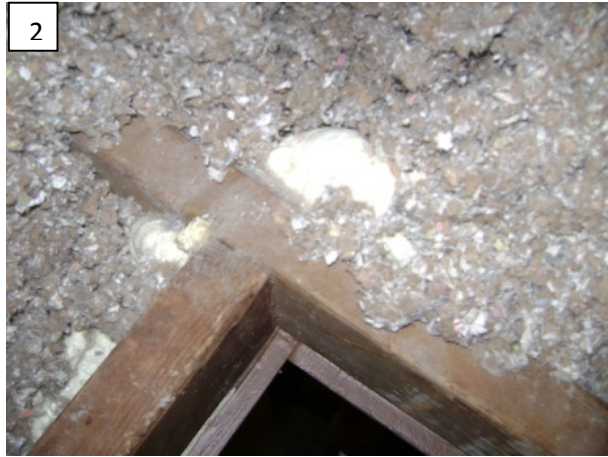
- The attic hatch has no fastening method. It depends on the lid's weight for an air seal. [1]
- The stick-on foam weatherstrip used on the attic hatch does not appear to be very durable. [2] & [3]
- The top of the attic hatch is not insulated. [3]
- The furnace vent stack is elbowed in the attic instead of going straight up through roof. Why? Did the design contribute to failure? [4]
- The attic cellulose blow was somewhat uneven but acceptable. [4]
- The attic wire penetrations were not air sealed. [5]
