Moisture Problems in Manufactured Housing

Manufactured homes are affordable to many. A study points the way to making them healthy by dealing with moisture problems.

by Neil Moyer

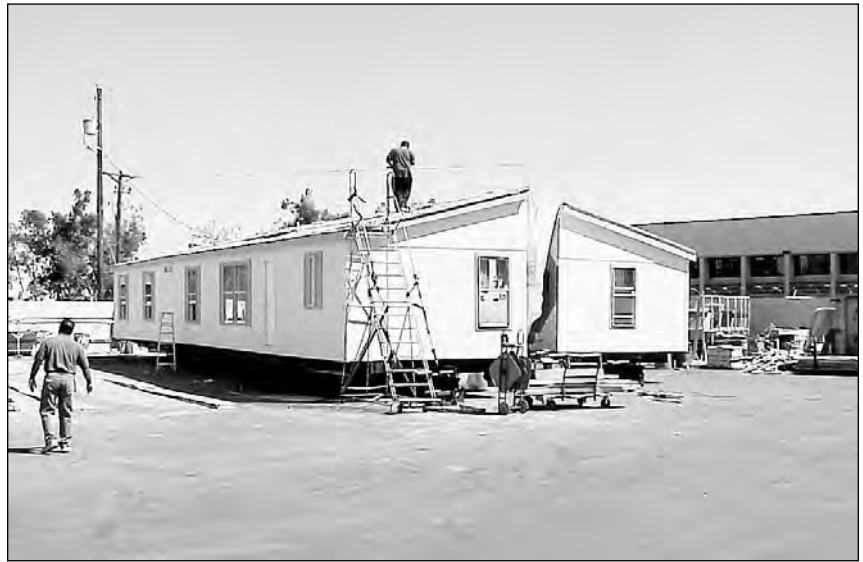
other connection points in the ductwork. When the AHU moves air through the ducts located under the floor, some of it leaks into the belly and eventually to the outside through tears in the belly board (see Figure 1). This loss of air creates a negative pressure inside the house and a positive pressure in the belly, because the return, being located in the home, has no such leakage. The negative pressure draws outside or attic air into the house through the numerous cracks and crevices connecting the inside of the house to the outside or to the attic. If this outside air is cold and dry, as it is in the winter-time in the northern United States, it will increase heating energy use and occupant discomfort. This situation will not rot a home in a northern

Figure 1. Supply leaks can cause positive pressures in the belly of manufactured homes. The resulting negative pressure in the living space can draw in moist air from the outside.
