A Recessed Can of Worms

by Larry Armanda and Steve McCarthy

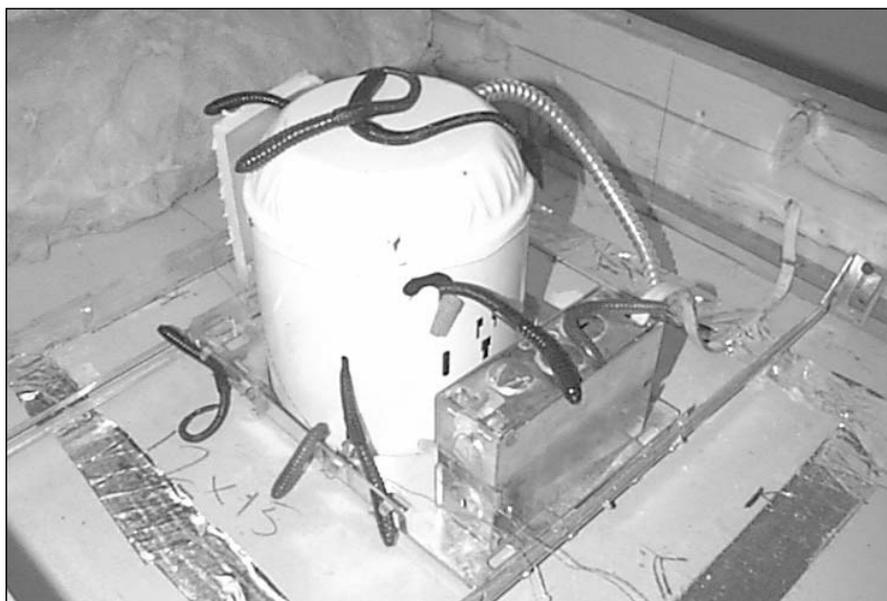
When we climbed up through the attic hatch, we were surprised by what we saw. The attic was partially floored with plywood and insulated with cellulose. Prior to insulating, the installer had carefully fitted 12-inch-tall sheet metal barriers around each light fixture. There were what looked like 56 short, open-

topped, sheet-metal chimneys protruding into the attic through both the insulation and the plywood floor.

A graphic description of our problem: a recessed-can of worms.

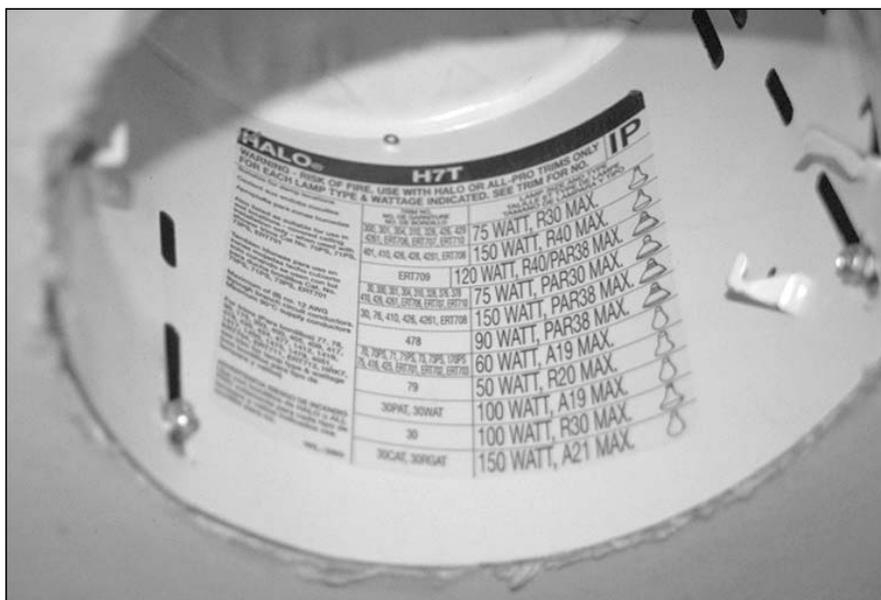
Manufacturers' trim and bulb recommendations are printed on the recessed-can housing.

If there is a lamp label inside the trim, make sure the proper type of lamp is installed. If there is no label, check the lamp socket for the maximum lamp wattage allowable. To help prevent a homeowner from overlapping the fixture (putting in a higher-watt bulb than the manufacturer recommends), mark the inside of the fixture adjacent to the lamp with the style and wattage of the replacement lamp. A-lamps should never be used in any type of recessed-can fixture. CFLs or PAR lamps are a safer choice.

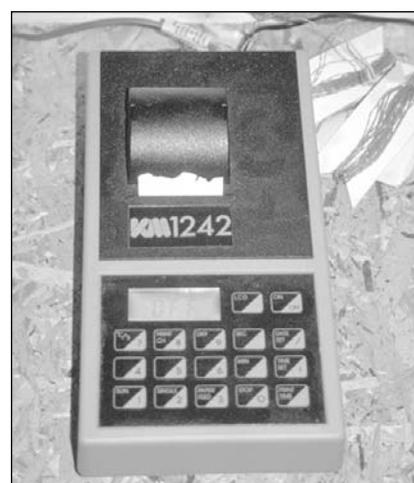
We installed 12-inch fiberglass batt insulation around, but not over the top of, the airtight box. Finally, we installed thermocouples in four different locations to allow us to monitor temperatures within, on and above the box. When the box was completed, we conducted three different tests to see how it would perform under different conditions and with different lamps. The results of these tests are shown in Table 1.

Temperature recording instrument.
