Avoiding Moisture Problems

Technical Update

By: Bill Van der Meer

February 2003

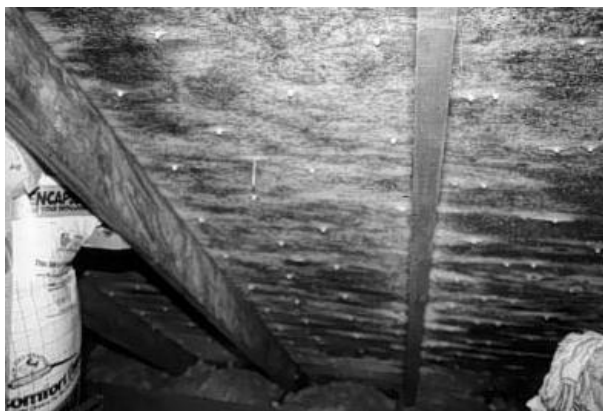
Saturated, warped and molded roof sheathing is often a result of warm, moist house air coming into contact with cold roof surfaces.

Upon visiting the home a team of investigators invited by the agency verifies that a worst-case scenario has developed. All wood surfaces in the attic are saturated including the first couple of inches of the newly installed blanket of insulation. Significant condensation is occurring on all glazing surfaces and mold has become well established on the wooden window sashes. Water stains are evident on the ceiling.
