Dry Notes from the Underground

Research shows that homeowners invite mold growth and serious health risks with a finished basement that has moisture problems.

by Don Fugler

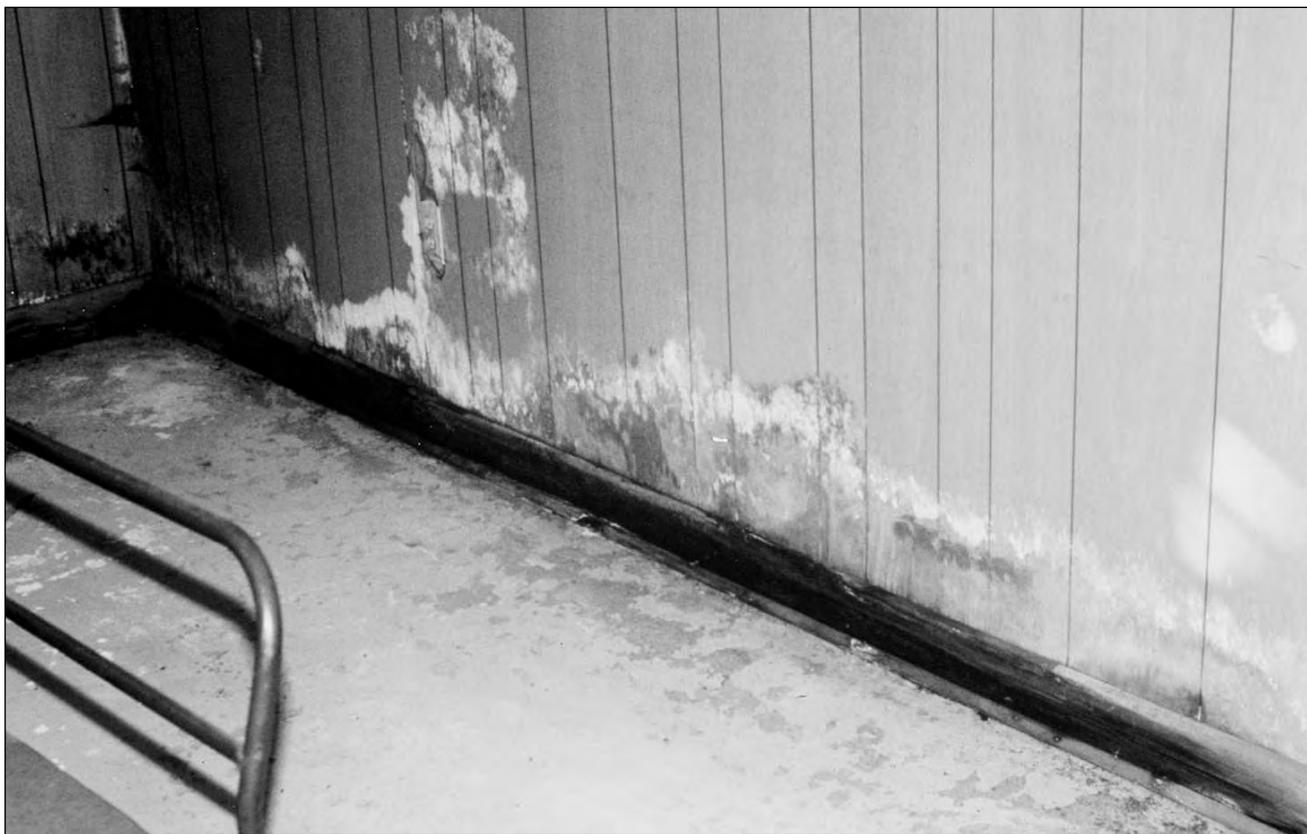
CMHC

Don't even think about sleeping in a basement with such extensive moisture damage.

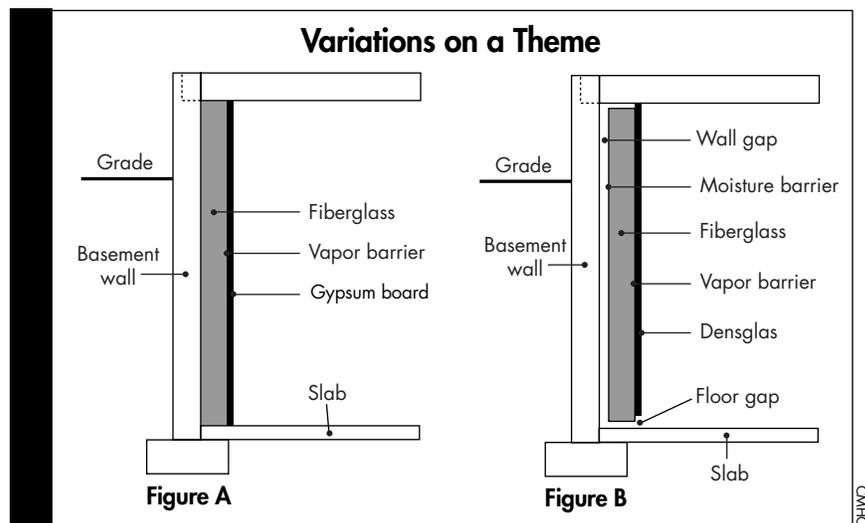
The wall systems tested were
Standard construction: Wood framing with fiberglass batt insulation, a 0.15 mm (6-mil) polyethylene vapor barrier, and painted gypsum board. Bottom plate rested on the concrete floor (see Figure A).

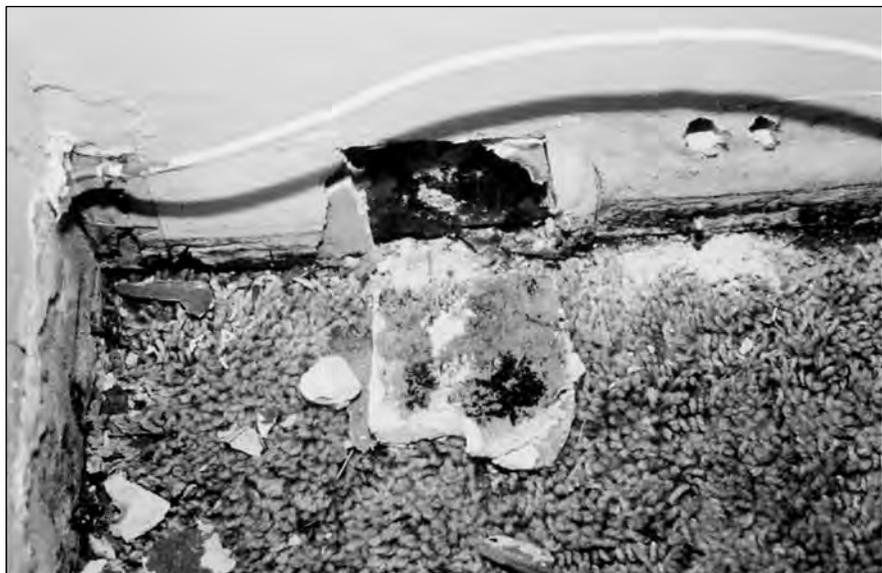
CMHC

Although this carpet was dry, mold was found inside the basement wall.
