Public Housing Breaks the Mold

Part II: Veterans Era Housing

In Part I, we discussed the particular moisture- and air quality-related problems of midrise housing, and we took a close look at two cases. Here we explore issues unique to Veterans Era Housing and present three cases where moisture problems were successfully addressed.

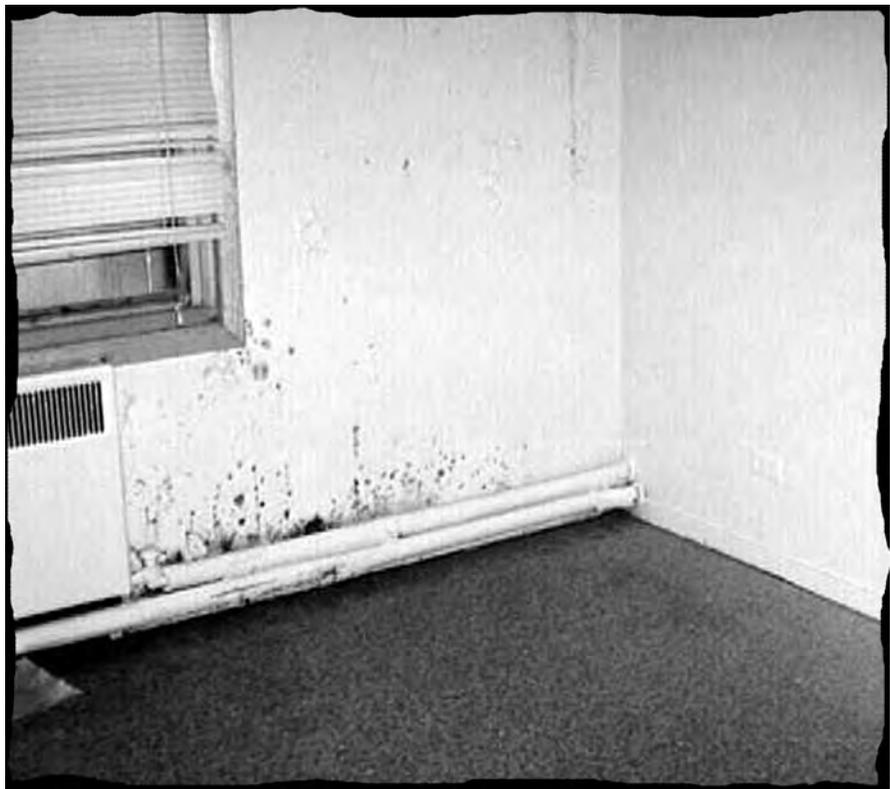
Mold growth on exterior walls was one of the most visible symptoms of moisture problems at this Cleveland Housing Authority apartment.

The housing authority had recently installed wood-framed replacement windows in the development, because tenants had complained that the old windows were leaking rainwater. Reduced air leakage through the new windows, however, caused moisture condensation on the windows and mold on the walls and ceilings.

Investigators concluded that high interior moisture levels, due to inadequate ventilation and to high moisture source strength, caused the sensation of dampness. They also decided that the mold and mildew, window condensation, interior paint damage, and plaster damage were caused by high interior moisture levels combined with cool surfaces.

The recommended solution was to reduce interior vapor pressure and to increase internal air flow.

Reduce interior vapor pressure. Installing controlled mechanical ventilation in each apartment would dilute interior moisture and other pollutants. We recommended installing exhaust-only ventilation to provide approximately 15 CFM per occupant, extracting air from the washrooms and stairwell/hallway areas, and exhausting this air to the exterior via ductwork. Ventilation should operate continuously in order to maintain interior moisture levels between 30% and 45% relative humidity at 72° F during the winter months.

recommended undercutting all interior doors 2½ inches (from the top of the floor covering to the underside of the door) to promote air change in the secondary rooms. The continuously operating exhaust fan would then induce the 2-3 Pa pressure differences neces-

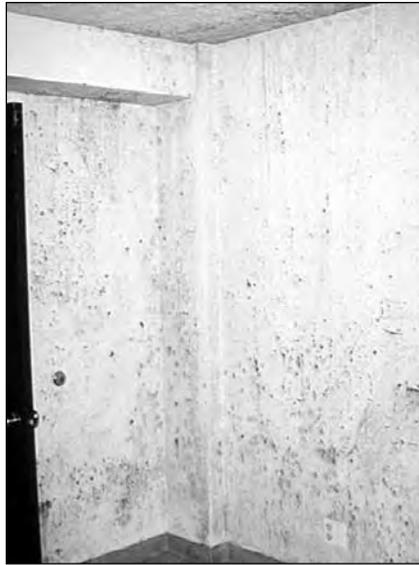
activities also implied high moisture generation in the apartments. Specific examples include hanging up laundry to dry indoors and heavy use of the installed gas stoves for cooking with inadequate kitchen exhaust ventilation (see Table 1). We observed mold growth at exterior corners and condensed water and water stains on window frames. The window stains indicated significant current and past condensation on the window glass.

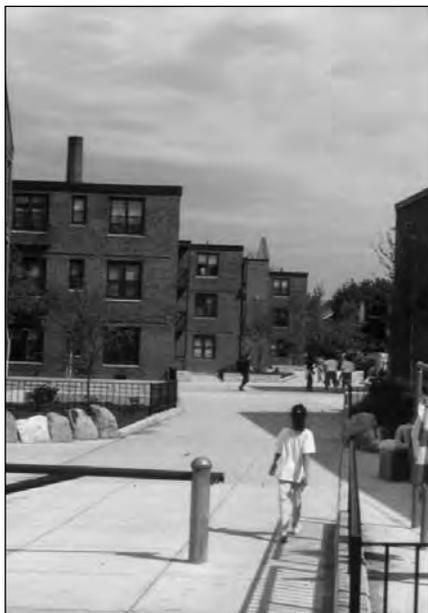
Strategically placed exhaust fans have solved most of the moisture problems at Merrimack Courts apartments in Lawrence, Massachusetts.

In a follow-up phone conversation with LHA's maintenance director, we confirmed that LHA believes that it has solved most of the moisture problems at Merrimack Courts. However, LHA management was unable to install a central ventilation system due to difficult access in the existing pipe chases. In lieu of the central ventilation system, LHA installed individual bathroom and crawlspace exhaust fans.

The 80 CFM exhaust fans were installed on the bathroom ceilings vented out through the upper sash of the bathroom window. The fans are hard-wired to the bathroom light switch and run whenever the light switch is turned on. In addition, LHA installed fourteen 2,000 CFM (at 1 inch static pressure) exhaust fans, one in each basement crawlspace. The crawlspace fans are hard-wired to

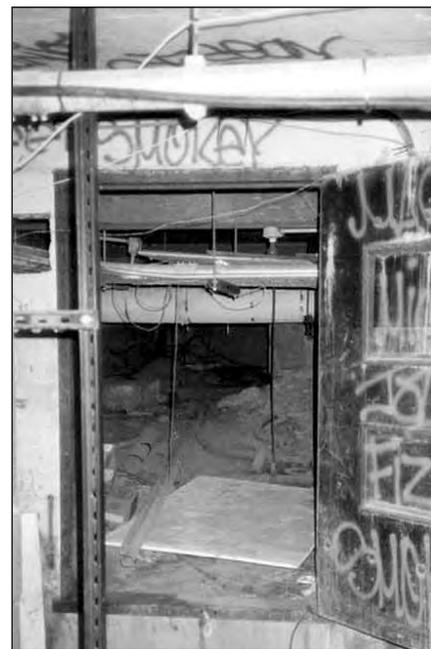
To reduce moisture levels in Merrimack Courts' moist crawlspace, 2,000 CFM exhaust fans cycle on for two hours, three times a day.

timer switches that cycle the exhaust fans on for two hours, three times per day. In retrospect, LHA should have installed small fans and run them continuously.

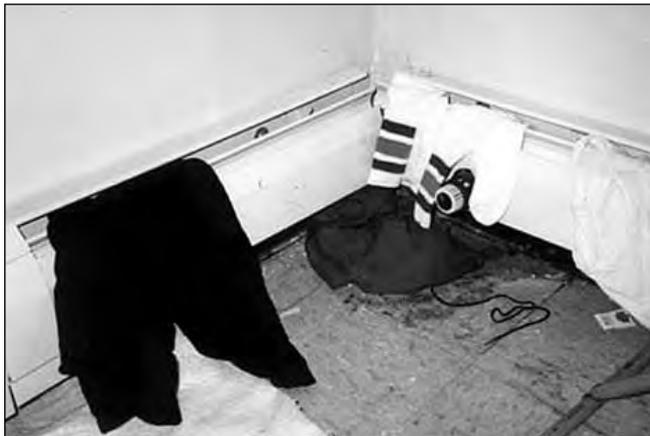
Residents can drive up indoor humidity levels by drying clothes on baseboard heaters.

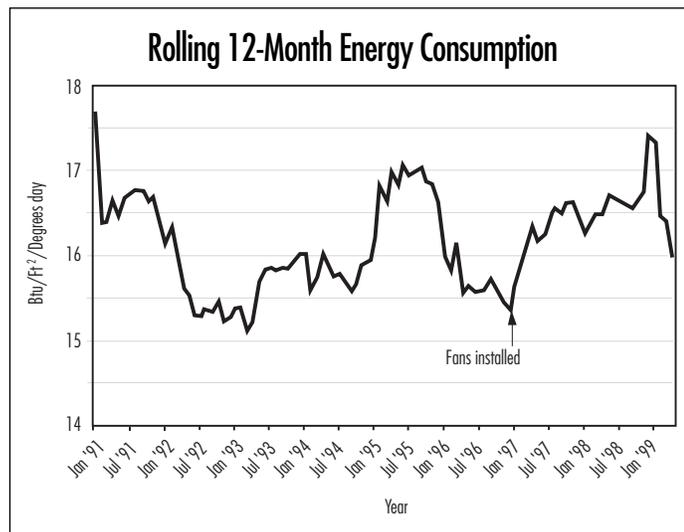
Figure 1 indicates the heating energy penalty attributable to LHA's bathroom and crawlspace exhaust fans and higher apartment temperatures. The chart tracks the rolling 12-month average energy consumption per ft² per heating degree-day at Merrimack Courts. LHA installed the exhaust fans in February 1997. Shortly after the fans were installed, the chart documents increased annual energy use from 15.5 Btu/ft²/degree-day to 16.5 Btu/ft²/degree-day. We estimate that the net heating energy penalty for the exhaust ventilation and the increased apartment temperature is about \$34 per apartment per year in gas costs (additional electric costs, if any, are not known).

Figure 1. Merrimack Courts' ventilation fans and higher apartment temperatures increased the annual heating energy costs by \$34 per apartment.

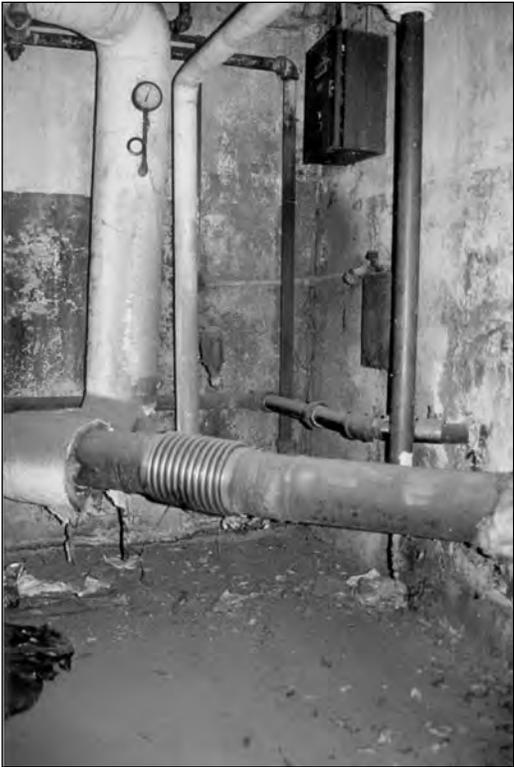
The 50-year-old steam heating distribution system was at the end of its life expectancy.

Repair water leaks. We recommended replacing the failed underground steam heating distribution system with individual gas-fired, high-efficiency distributed forced hot water heating and DHW systems, one per building. We also recommended installing low-volume toilets and other measures to help pay for the cost of repairing or replacing the leaking potable water and heating system piping with additional water cost savings. Water meters should be read regularly to monitor the consumption at West Broadway. Future water leaks should be identified and repaired quickly.

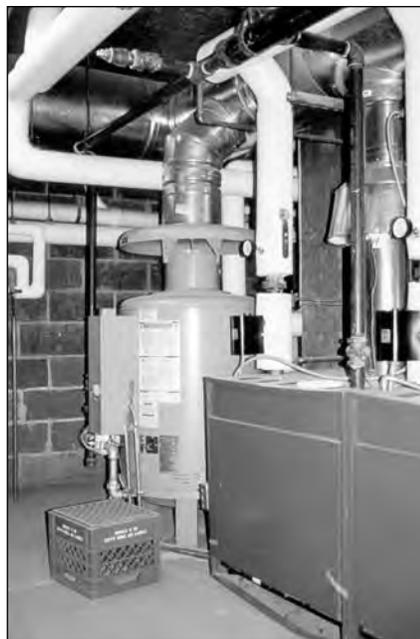
The new boiler and domestic water heater at West Broadway helped to improve apartment temperature control.

BHA completed an energy performance contract project at West Broadway Apartments in December 2000. Measures installed under the contract include individual forced hot water boilers—one per building—and low-volume toilets,
